**MEMORANDUM**

Subject: 5 & 5-1/2 Albion Street, Amesbury, MA

Re: Site & Building Evaluation

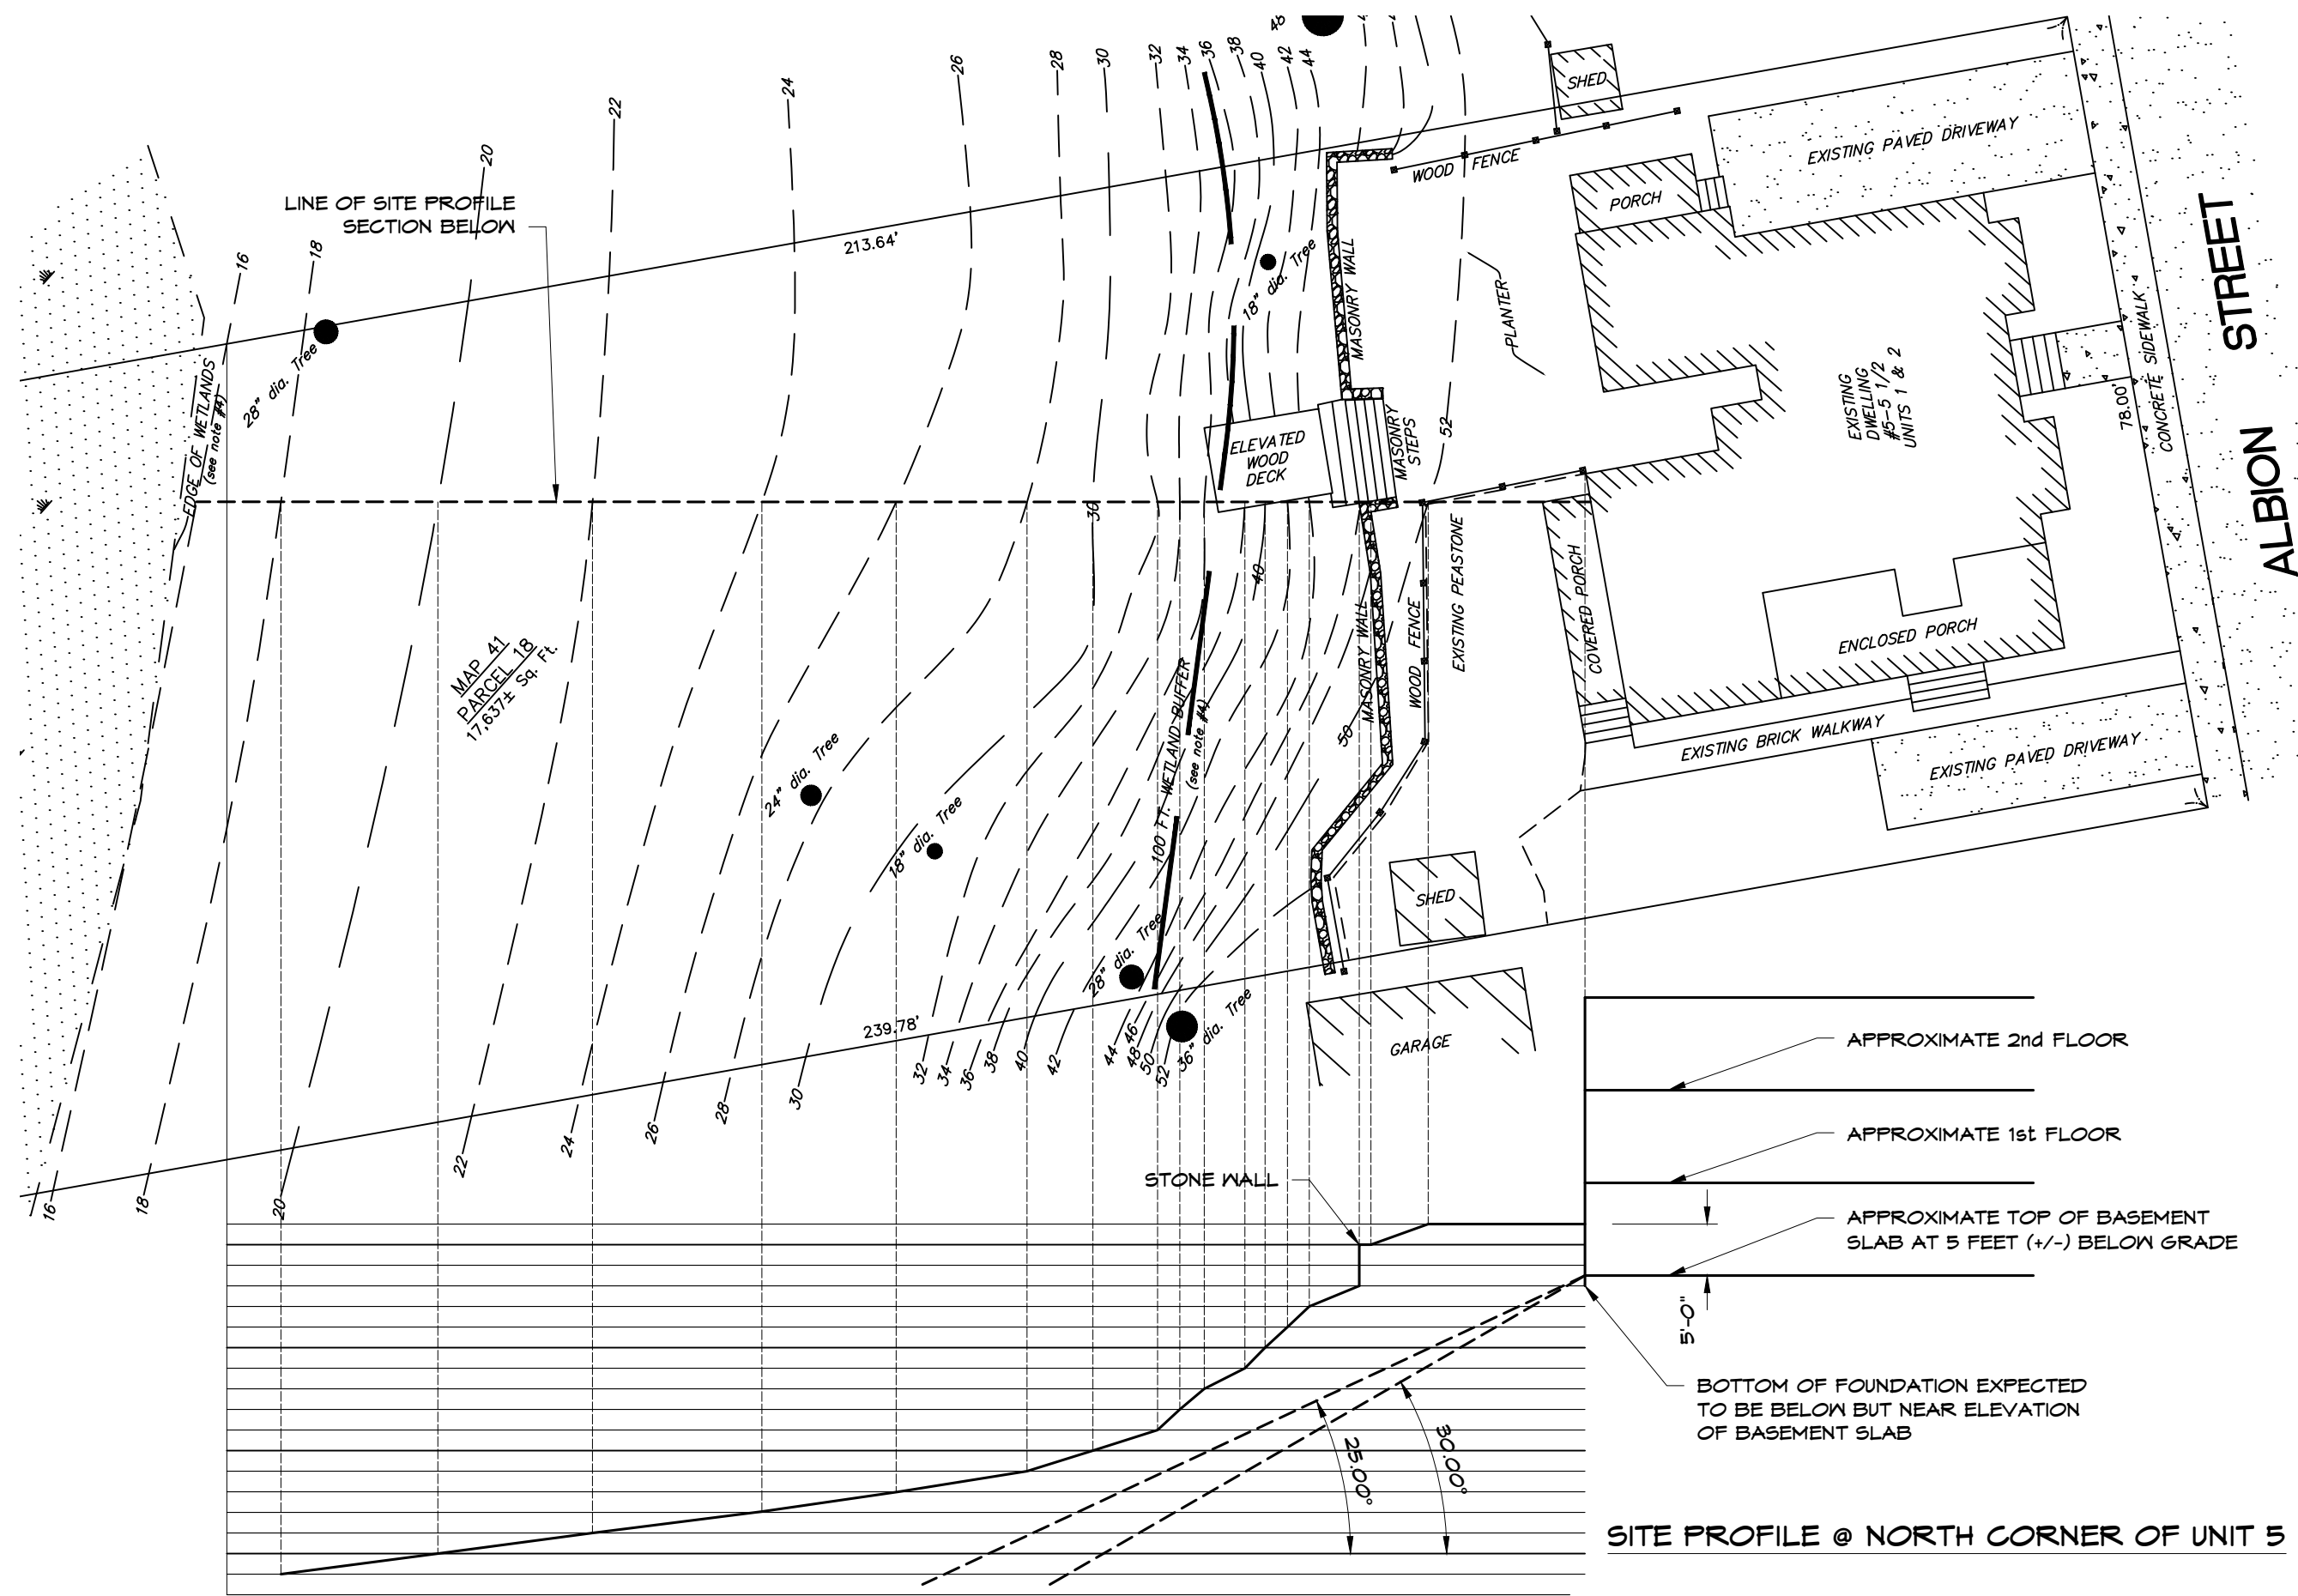
SITE PROFILE @ NORTH CORNER OF UNIT 5

The profiles are a cross section through the site, at the lines from the plan, that illustrate the angle or steepness of the slope, from the top, by the house, across the back patio areas, to the stone wall, which is noted, and then beyond and down to the pond. To the right on each profile, I have shown the position of the house and also the depth of the basement slab below grade, which is where the building foundation bears.

Since it is the bottom of the foundation walls where the load of the house structure bears on the subsurface soils, I have added dashed lines at angles of 25 and 30 degrees, on each profile of the slopes, extending from the outside corner of the house, at the foundation level. The soil under the house and the soil under the dashed line represents the limit of the subsurface soils that either bear the load of the house and/or help restrain the bearing soils by supporting these from the sides. Considered another way, you could theoretically remove all the soil above the dashed lines and the house would still be supported and stable.

What the profiles attached here show us is that, at both locations considered (which are both "worst-case" conditions for each unit) the building is not at all endangered, or even influenced,

by the steep slopes behind the house. That is, there is sufficient soil under and adjacent to the house, under the dashed angled lines, to safely and soundly support the building structure. This evaluation shows that the building is very unlikely to be compromised, or even affected, by the steep slope and/or the existing retaining wall structure.

However, these profiles also demonstrate that the slope of the land below and behind the stone wall is steeper than either angle of repose and, therefore, likely not a long-term stable condition, as we have already seen from the movement and damage that the stone retaining wall and the stairs have suffered. That is, we could not draw this same angled line from the bottom of the retaining wall and reliably demonstrate that the soil could support it, unless it was deep enough, below grade, to bear on stable soil within that angle of repose. It is unlikely this is the case – it is probably supported at a shallow depth and is also working to retain the soil behind it, which just adds further lateral loads, essentially pushing it down the slope.
