## Wetland Consulting Services

August 16, 2022

RE: Monitoring Report 53A South Hunt Road Amesbury

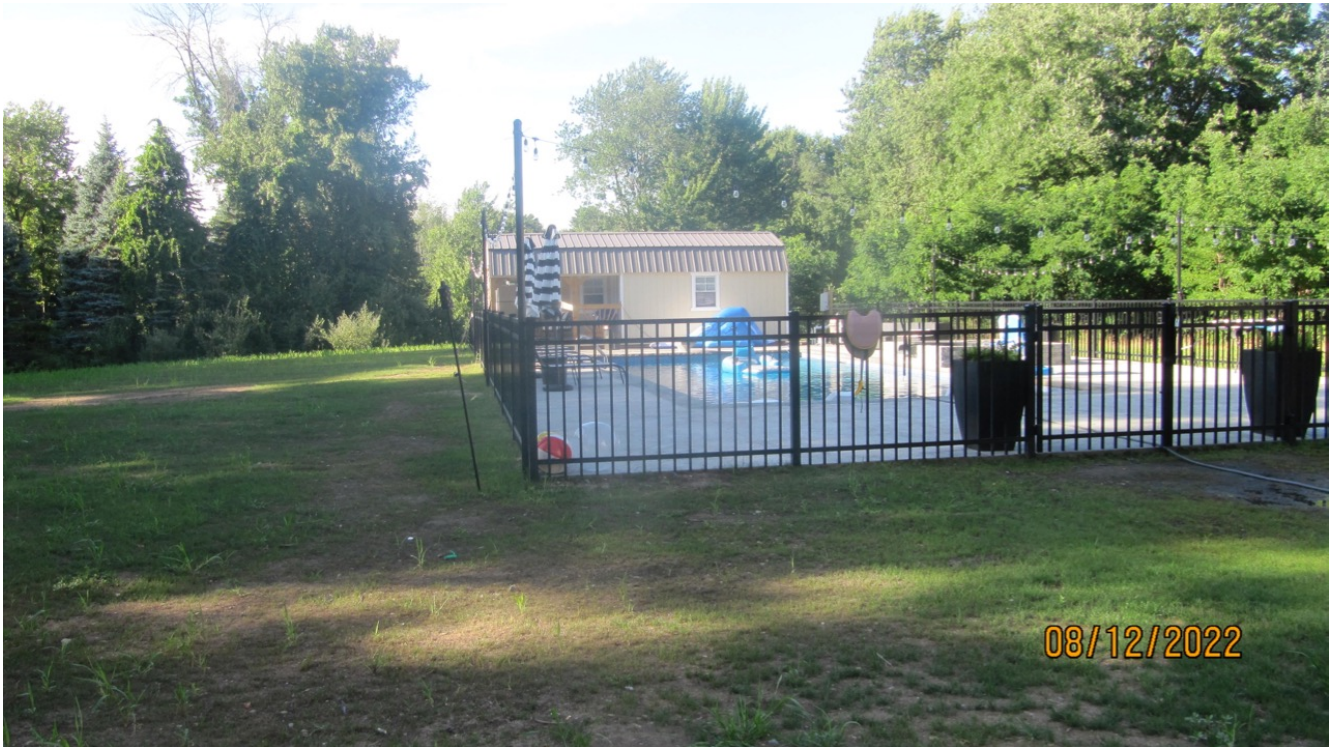
As you requested, I am providing this second monitoring report for the above referenced site. On 08/12/22 I visited the property. No residents were present at that time. This is my third site visit to the property. All work on the pool appears complete including the construction of a pool shed (see Photo A).

Photo A. Pool and pool shed.

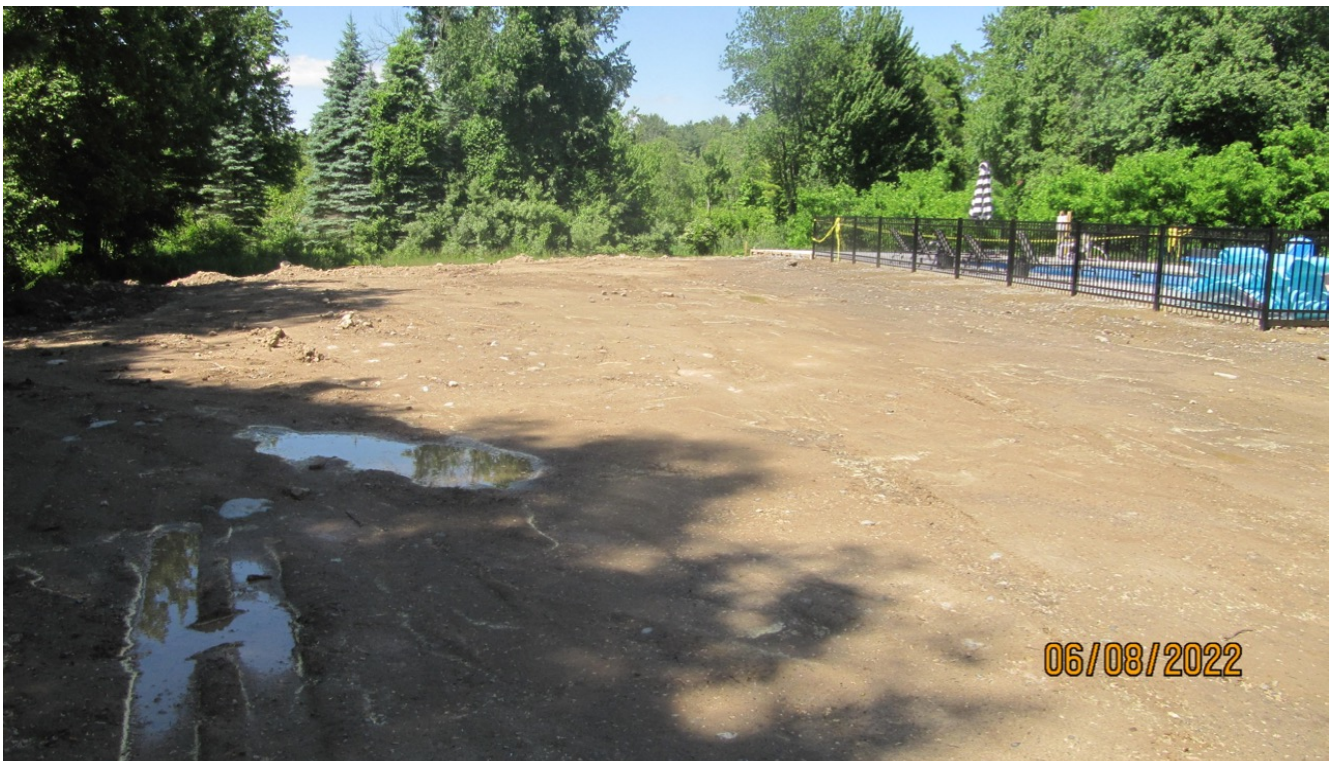
The site has been seeded (see Photos B and C), but current drought conditions are limiting the growth of the new grass. A sprinkler system was being installed during my June site visit, but it is unclear whether it is being used in this area. Since no residents were present, there was no one available to ask if the area was being watered.

Photo B. Site before seeding.

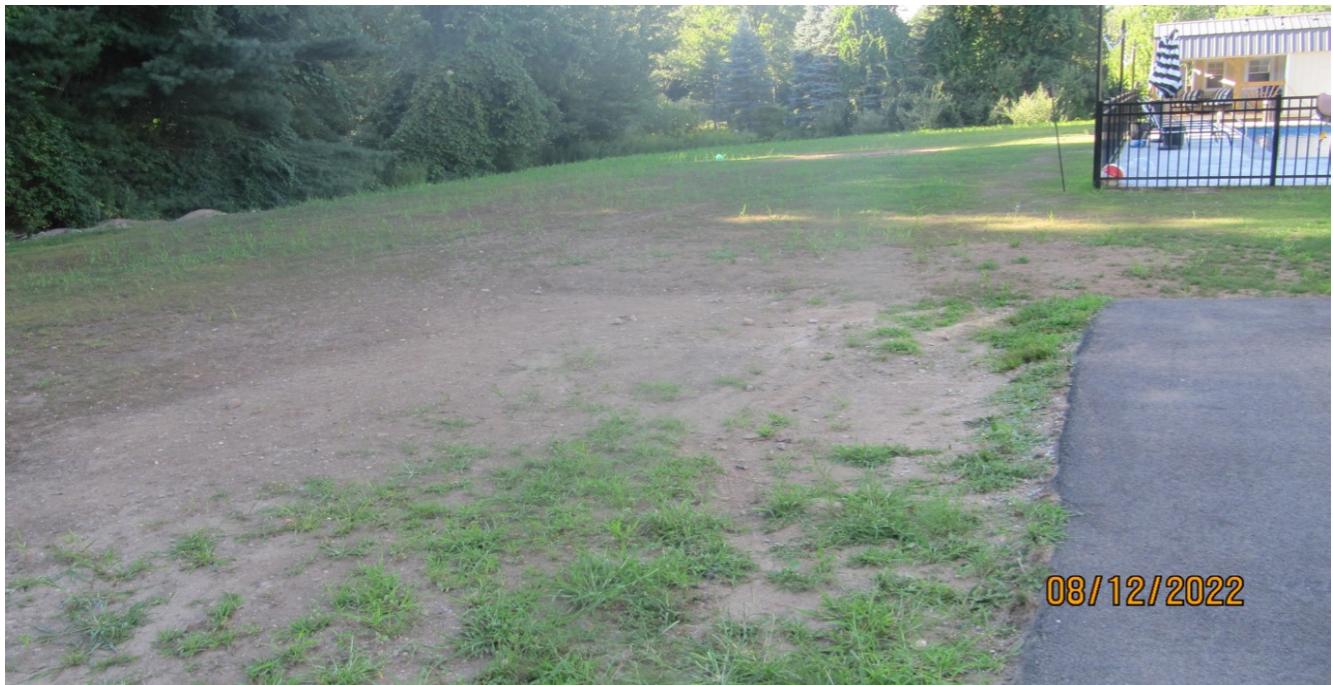
Photo C. Grass is starting to grow, but the current drought conditions are limiting the growth of the new grass.

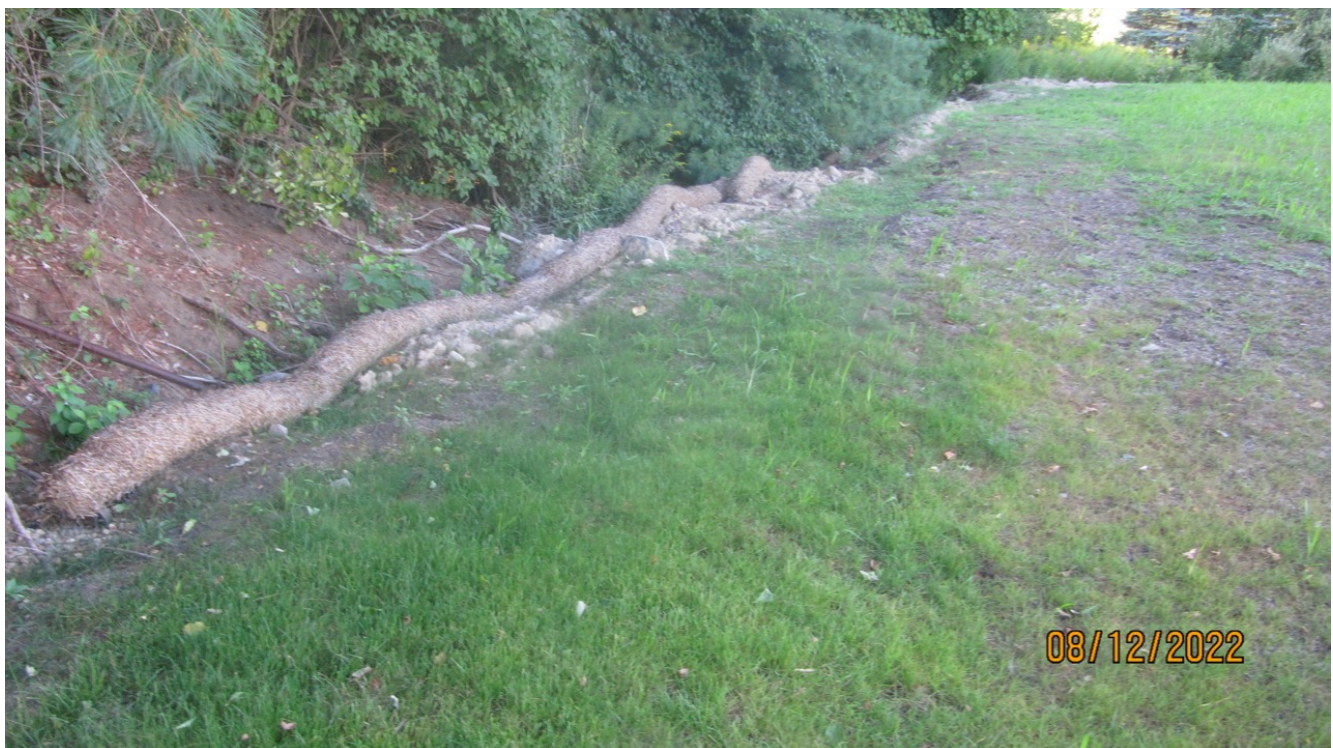
Erosion control (coir logs) have been installed around most of the perimeter (see Photos D and E), but the logs have not been staked as was recommended in my June report.

Photo D. Coir logs still in place, but stakes in the logs were not been installed as previously recommended.

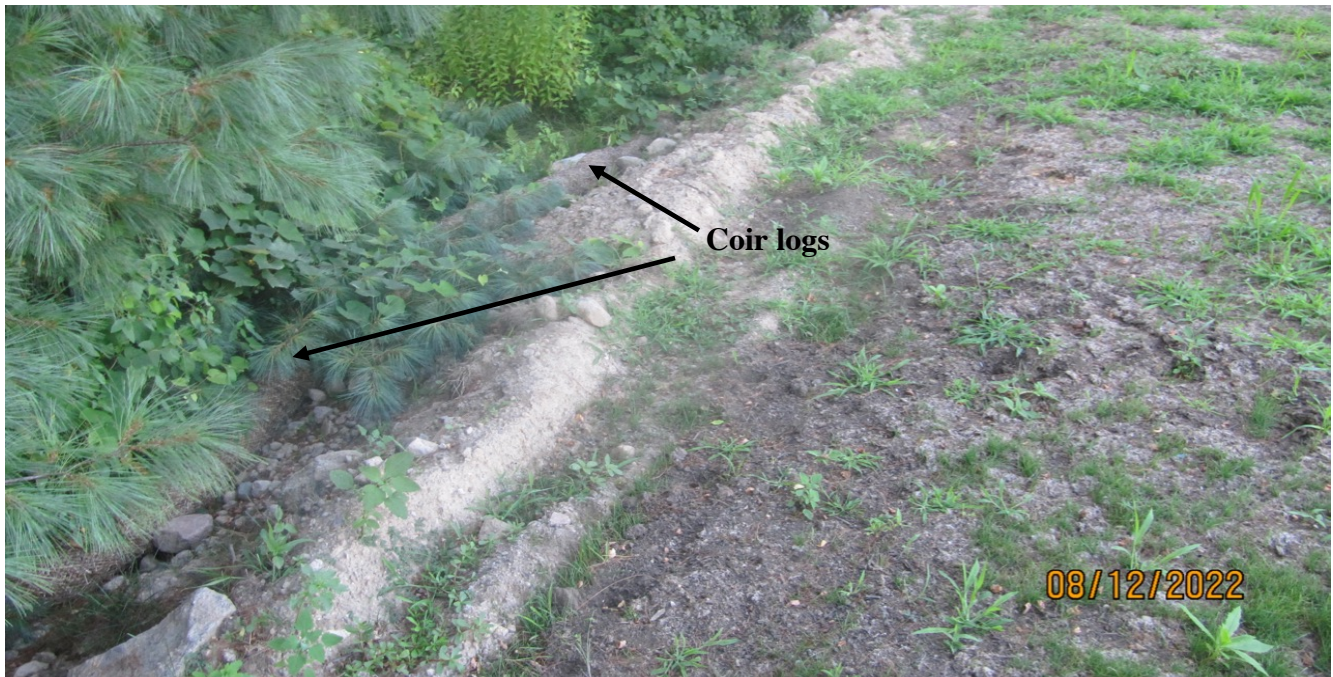
Photo E. Edge of fill still requires regrading.

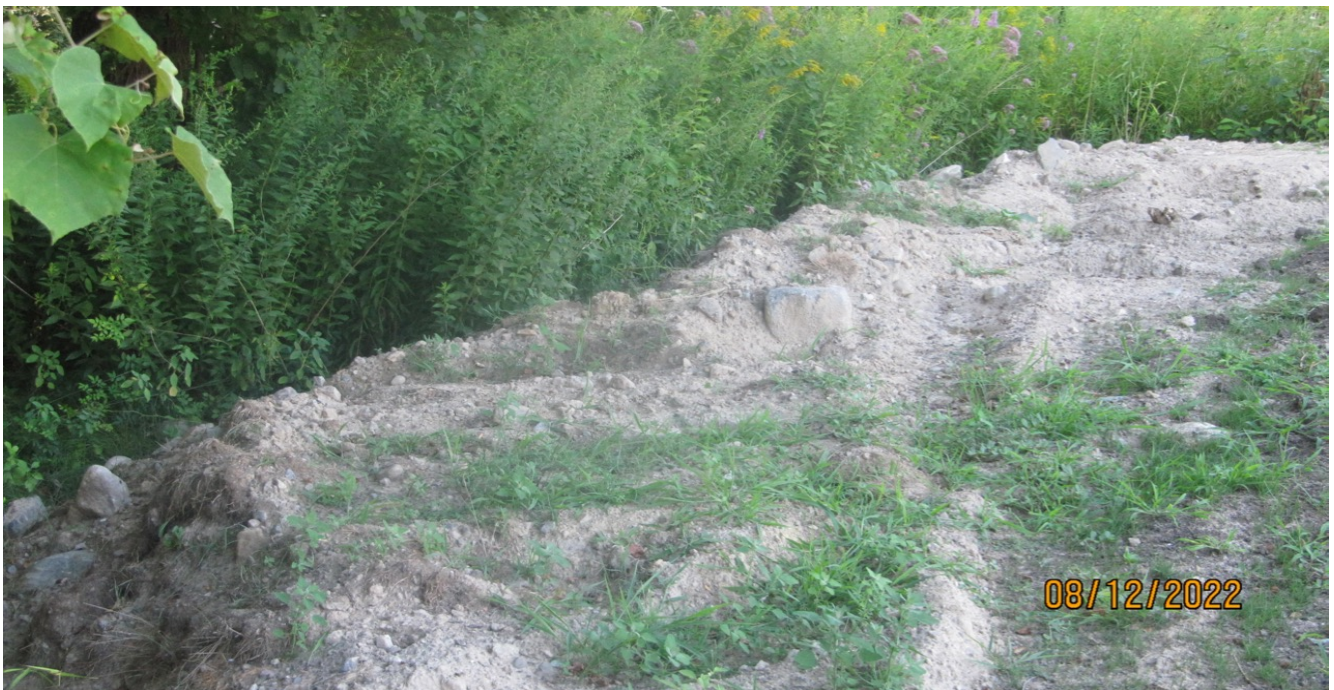
Finally, the outer edge of the filled area remains unstable and needs to be regraded and seeded (see Photo F) as it does pose a potential erosion problem during a heavy rain. Fortunately, the drought has not created an erosion issue at this time. Once the bank has been regraded and seeded, it would be beneficial if it were covered with straw.

Photo F. Edge of fill still not regraded at northwestern edge of fill area. No coir logs were installed in this area as recommended.
