## **Wetland Consulting Services**

# **Monitoring Report**

Subj: 53 South Hunt Road Amesbury

Date: June 29, 2022

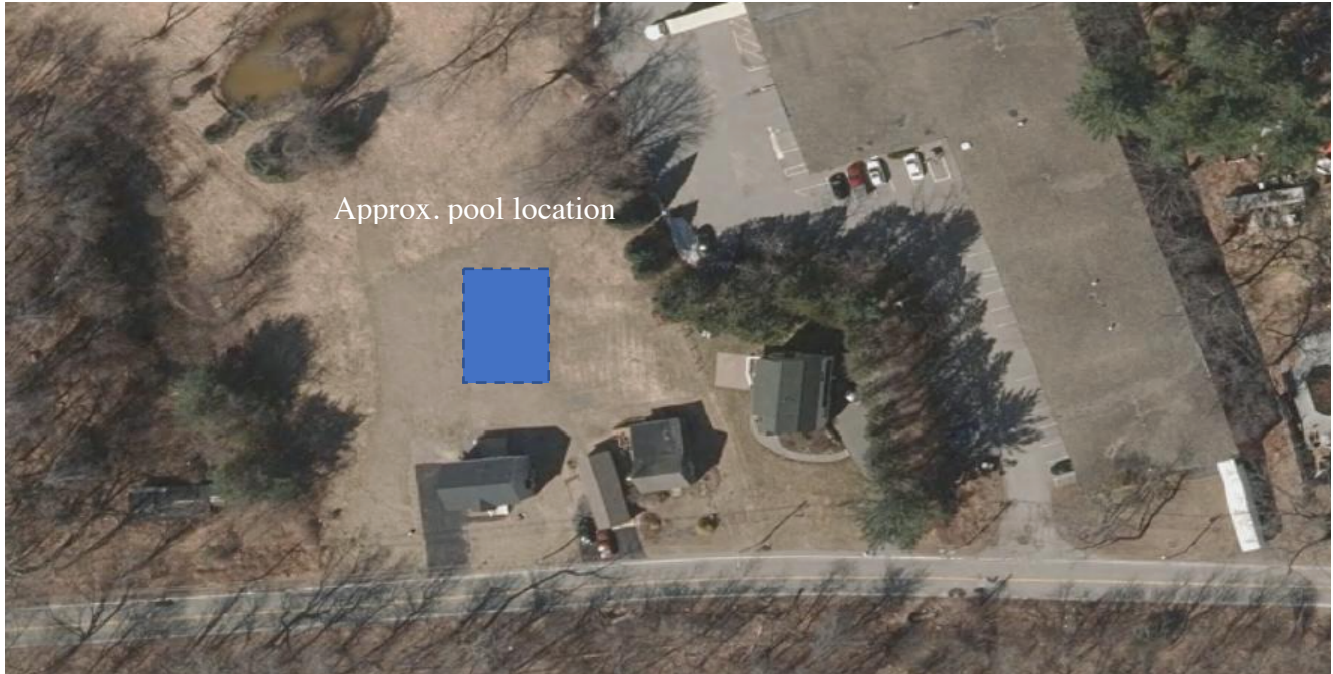
Photo A. 2019 aerial photo of the 53 So. Hunt Rd property showing approximate location of the pool.

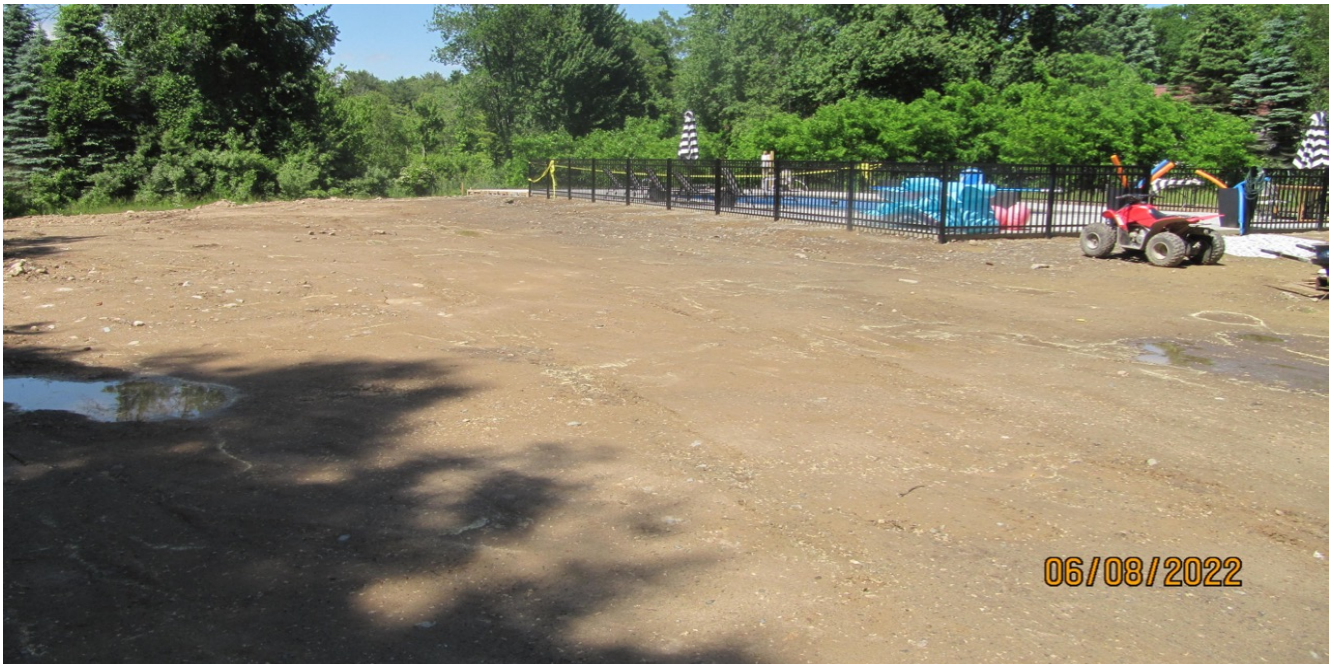
Photo B. Southwestern end of property after being filled with sand and gravel and then regraded,

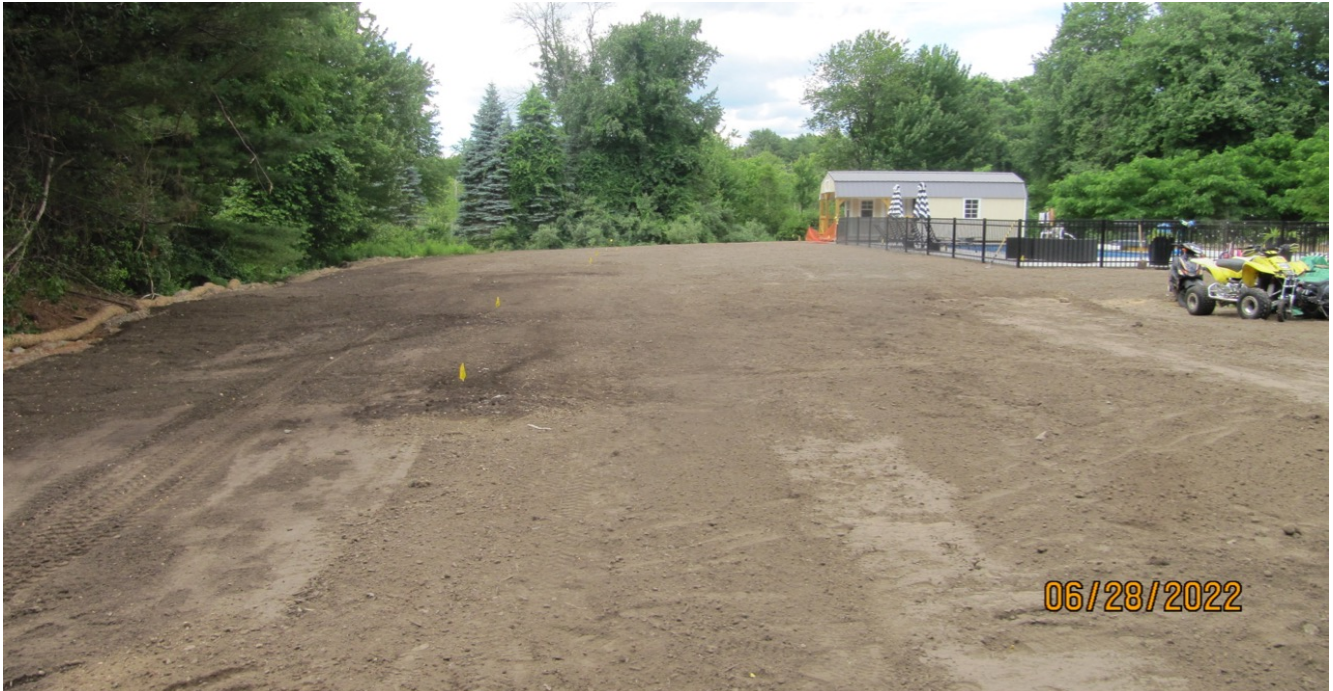
2- The project area has been covered with loam (see Photo C). The sprinkler system is currently being installed (see Photos F and G). Could not determine if the area has been seeded which is likely being delayed until the sprinkler has been fully installed.

Photo C. Property loamed and sprinkler system being laid out.

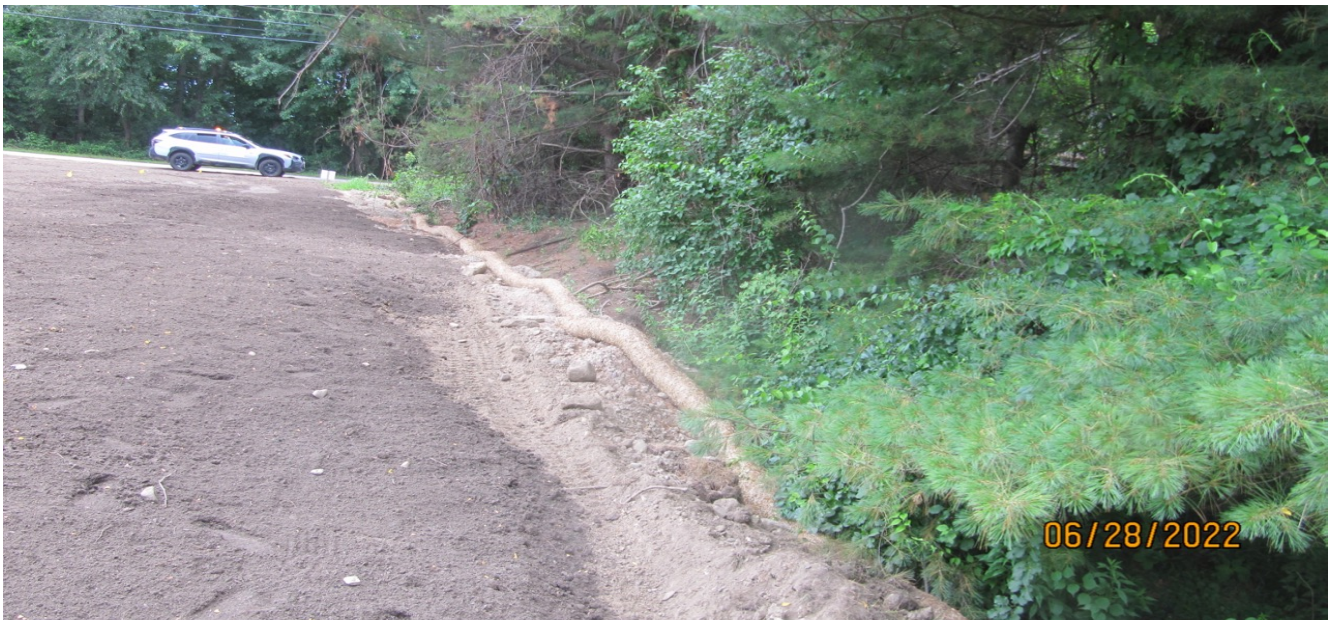
1- the project area was filled with sandy gravel and graded flat. No erosion control was installed, but the property owner has since surrounded the work area with coir logs (erosion control). The coir logs, however, should be staked in place (see Photo D).

Photo D. Coir logs installed around perimeter of regraded filled area. Coir logs should be staked in place.

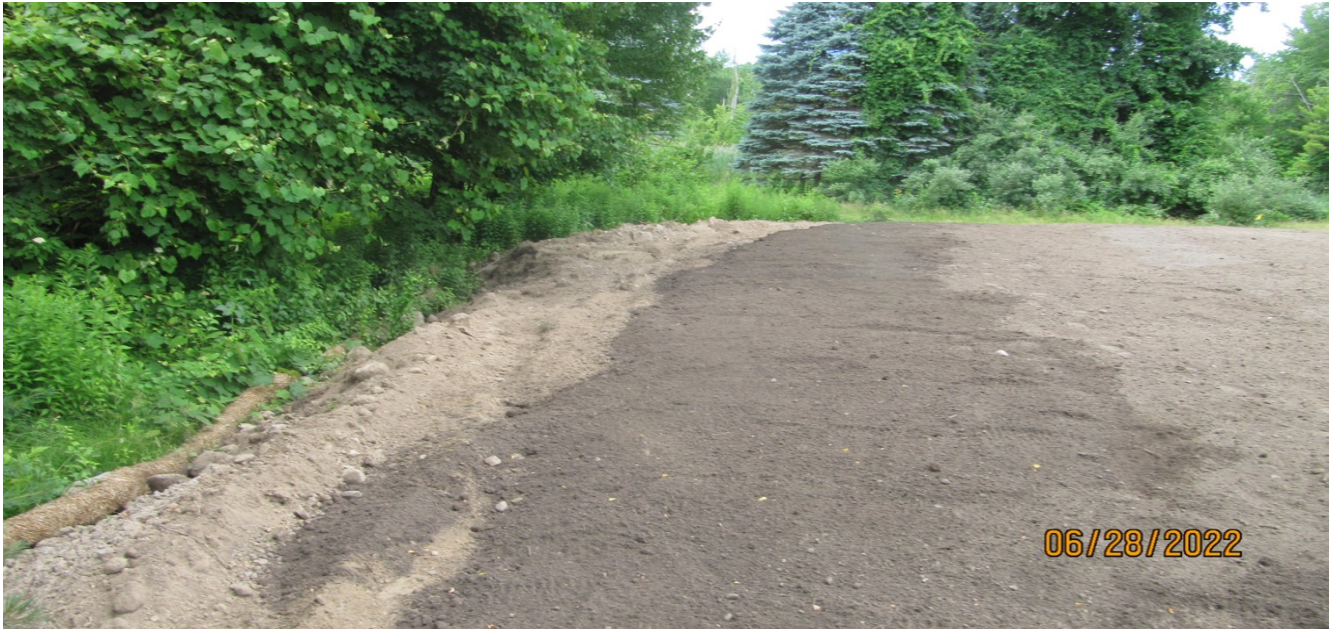
Photo E. Edge of filled area after loaming. Edge needs regrading and stabilization before coir logs can be removed.

3- The edge of the fill area needs to be regraded. Once regraded it should also be loamed and seeded (see Photo E).

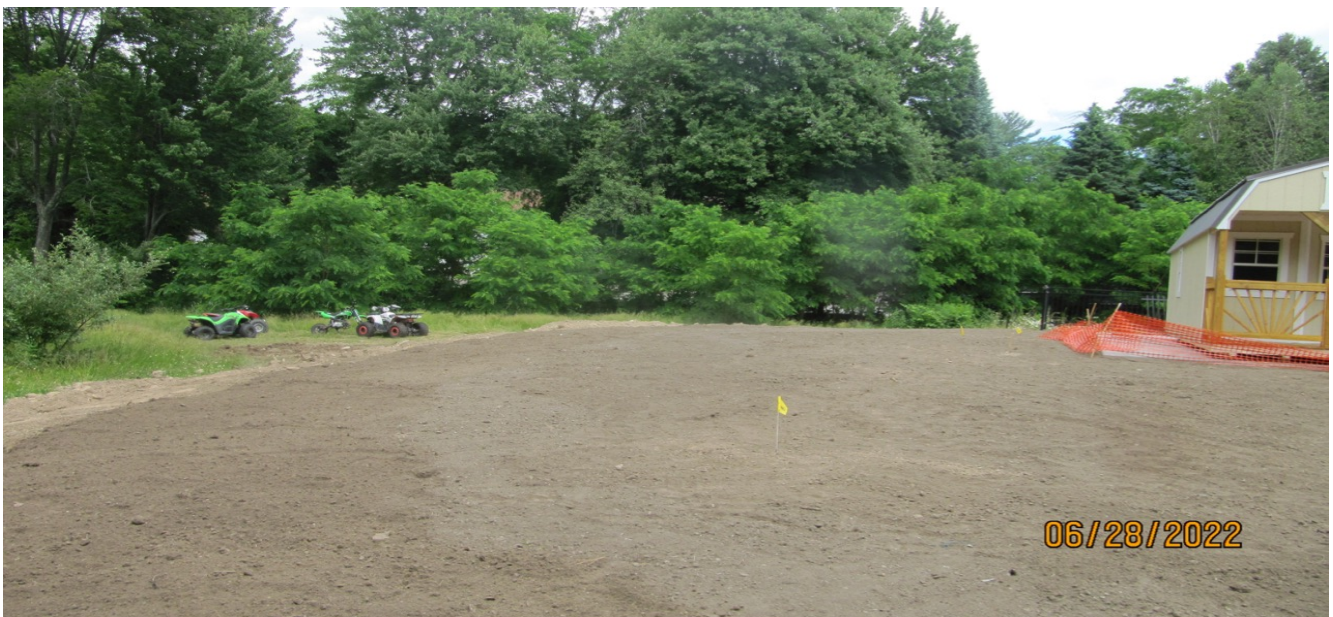
Photo F. Property loamed and sprinkler system being laid out.

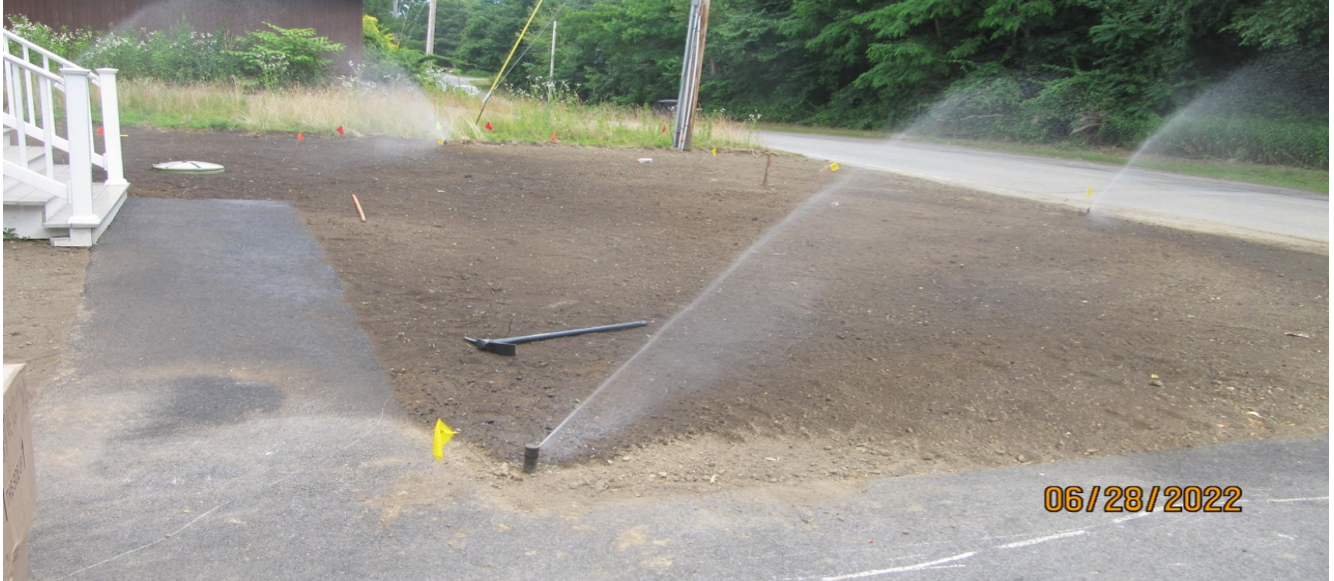
Since the 06/08/22 site visit, the property has been totally filled with sandy fill, and now filled and regraded with loam. A sprinkler system was being installed during the 06/28/22 site visit (see Photo G).

Photo G. A portion of the new sprinkler system installed in the front yard.
