## **Trails Assessment Report City of Amesbury**

Prepared by Woodsman Inc  
Site Visit Dates: 8/23/2024, 9/12/2024, & 9/13/2024

**Town Forest &  
Margaret Rice Conservation Area**

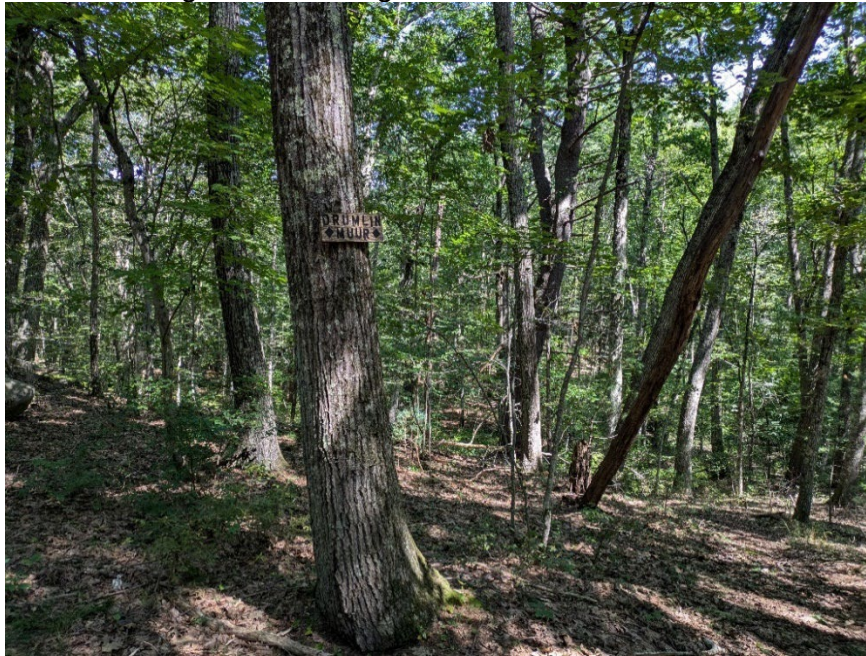
**Point 7** – There is a trail sign with the name Drumlin Muur, while on the Amesbury Trails website the trail is named Big Rock, creating confusion.

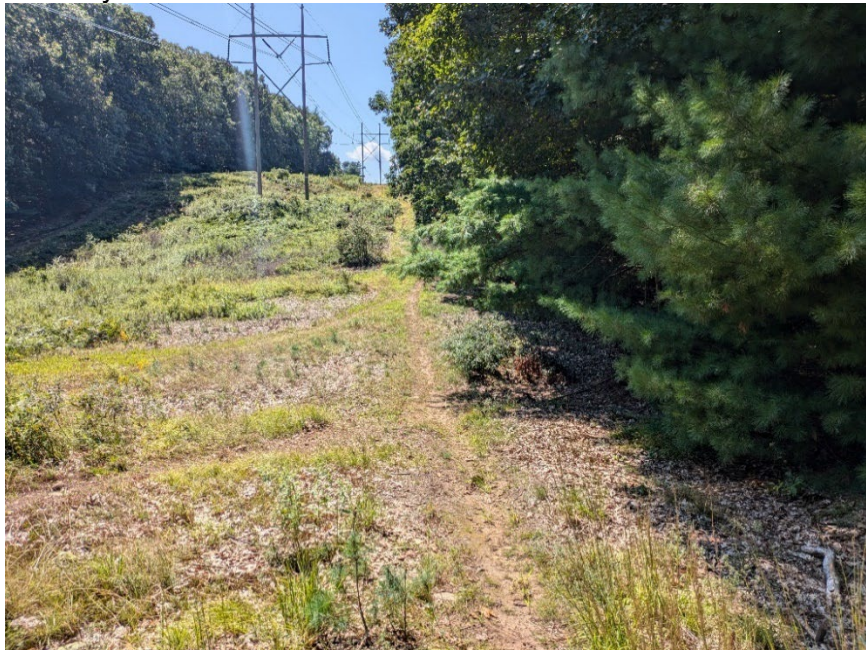
**Point 10** – An unmarked intersection. A stake with a blaze could be placed into the ground to let users know where they are.

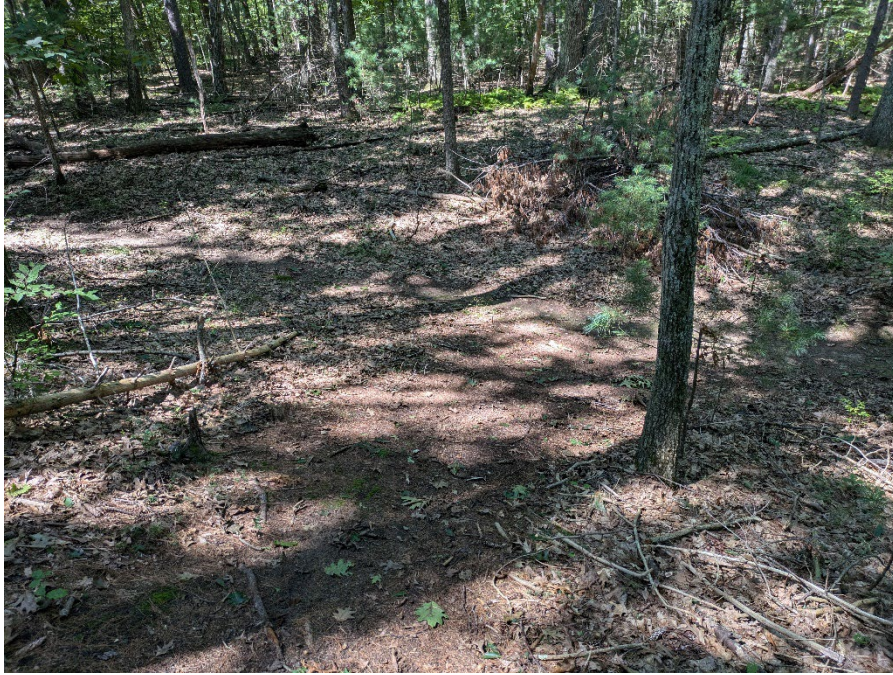
**Point 11** – An unmarked intersection. Blazes will let users know which trail is which.

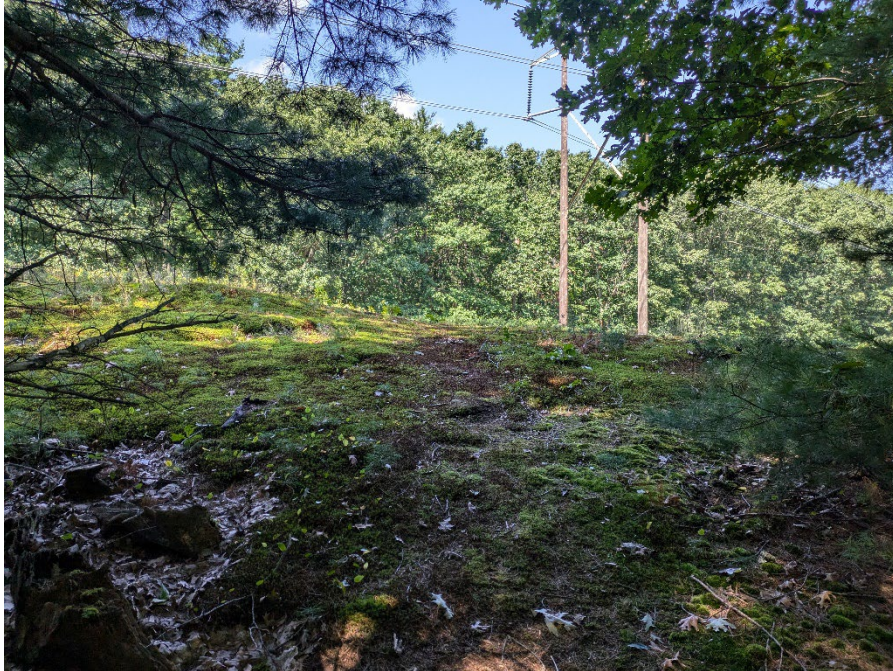
**Point 12** – A trail across the powerlines near an intersection. Using blazes painted on wooded stakes will reassure users that they are on the trail in confusing areas, such as powerlines.

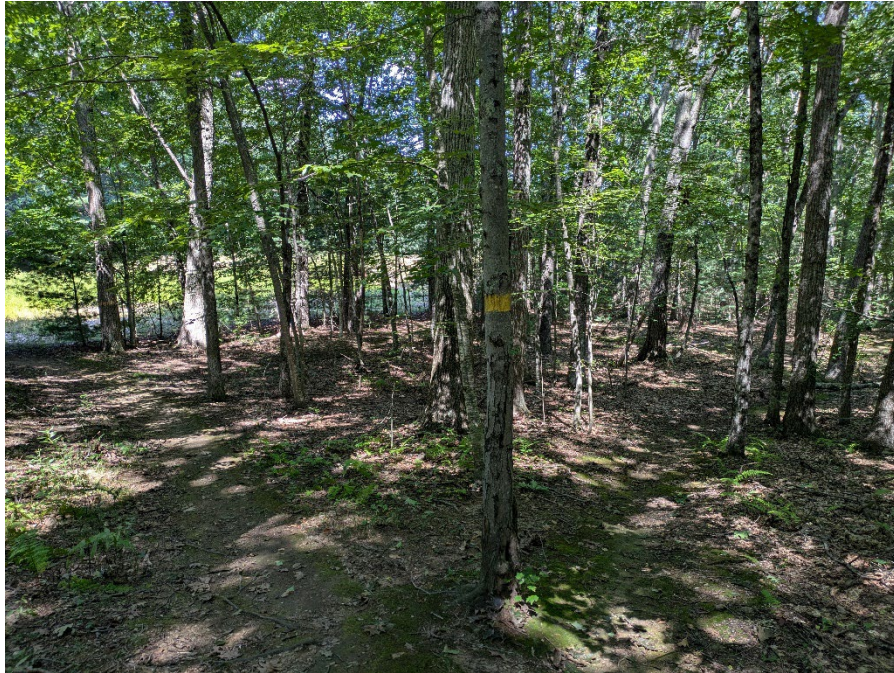
**Point 13** – A confusing intersection. In this location there are yellow trail markings heading down both branches of an intersection, but according to the trail map they should only be on the right trail.

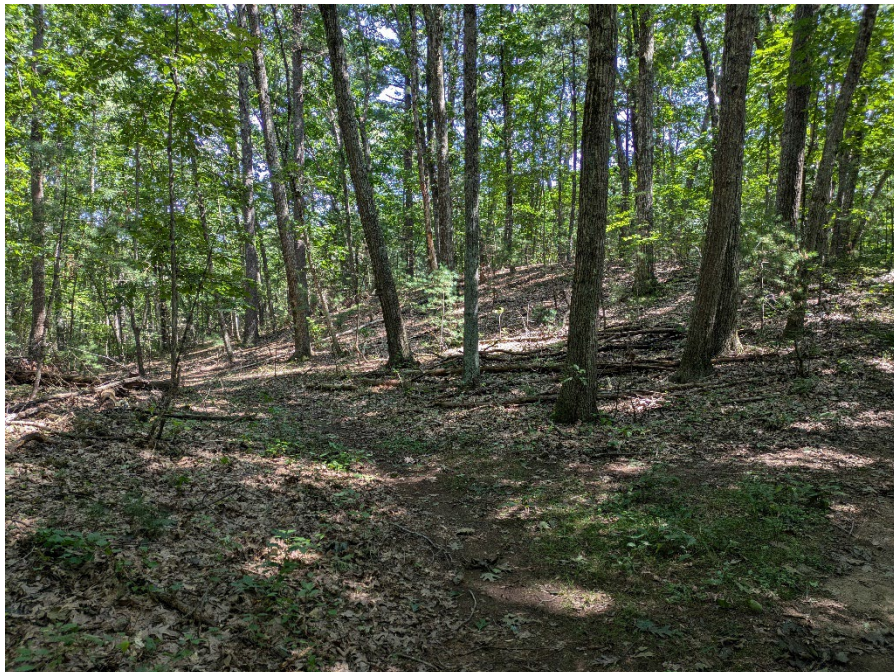
**Point 14** – An intersection with no blazes or signage so the user does not know what trail they are on.

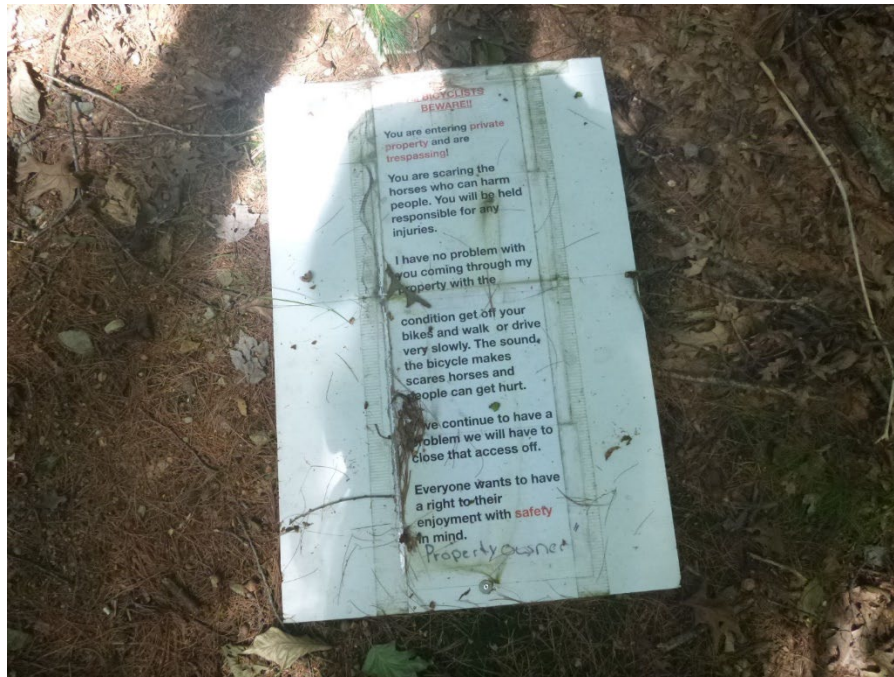
**Point 27** – A spur trail leads off town land onto an adjacent horse farm. The sign below was found on the trail discussing users scaring the horses, this spur trail could be closed to avoid future conflicts.

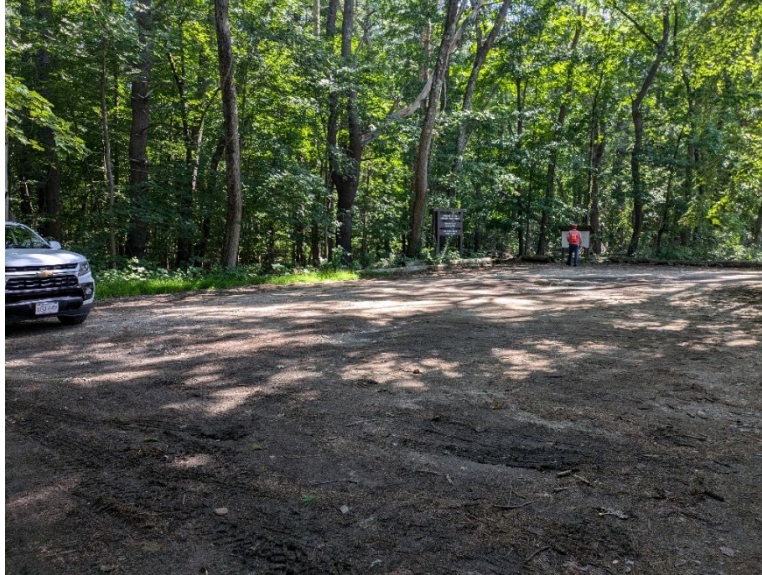
**Point 1** – The current parking lot could be graded and improved with a gravel surface. This will reduce mud and puddles in the parking lot and provide a better surface for parking. The photo below shows the current surface of the parking area.

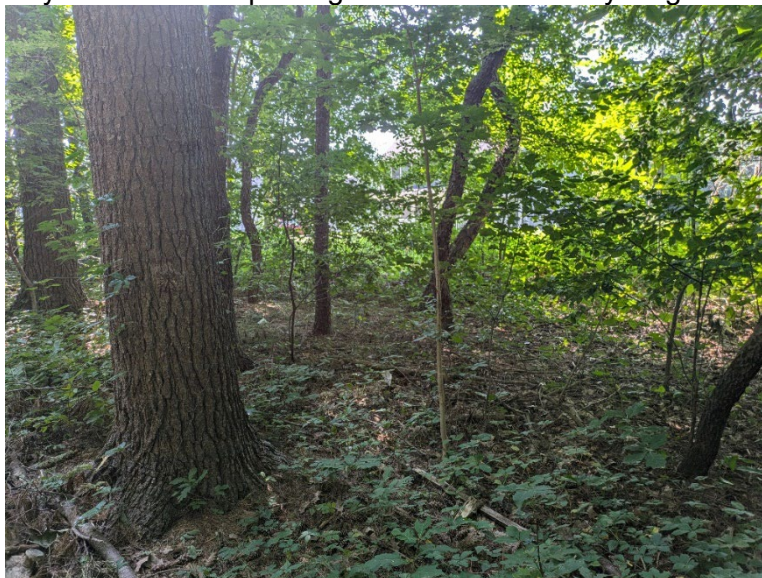
The photo below shows the vegetation currently growing between the parking area and the road. We suggest that the small trees and brush be removed from this area. This will serve two purposes, first it will allow people driving by to see that the area is there and available for public use, second, this will improve public safety. With the vegetation removed a police officer driving by on patrol can easily look in on the parking lot and ensure everything is well.

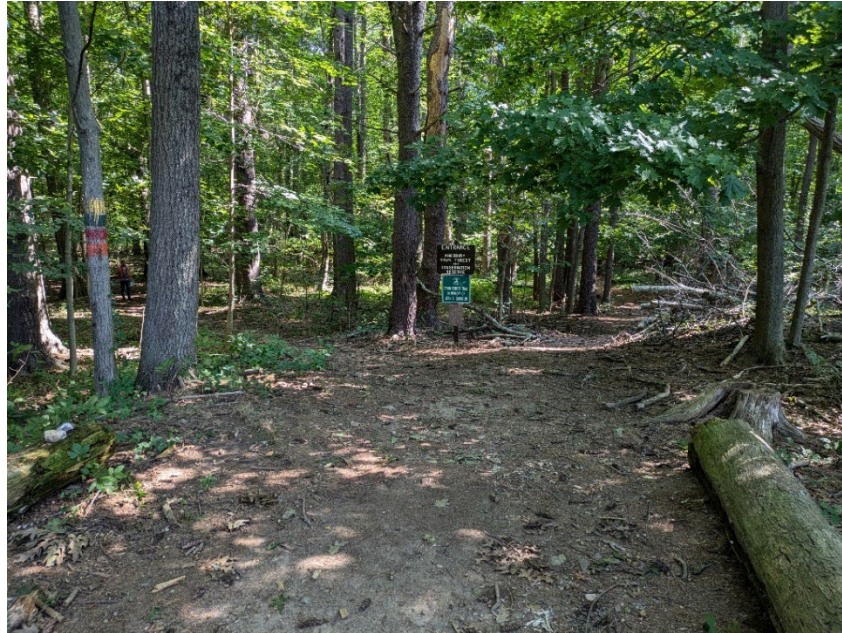
**Point 2** – The photo below shows the trail head just north of the parking area. Water is flowing from the parking area down onto the trails. The parking area should be graded so that water is directed away from the trails.

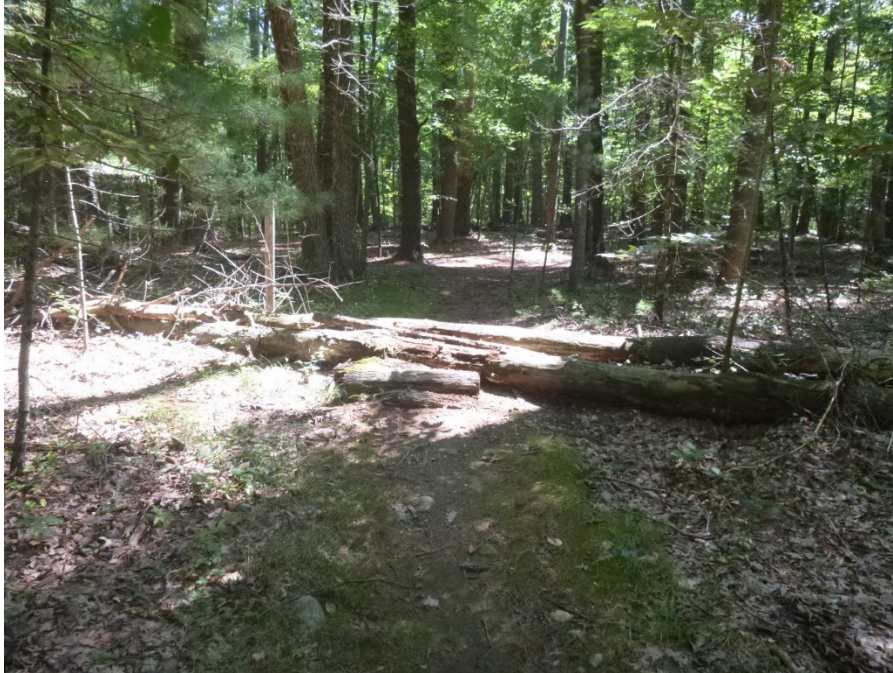
**Point 54** – There is a fallen tree that has been bridged by logs with users. This creates a hazard in the trail that may not be navigable by all visitors.

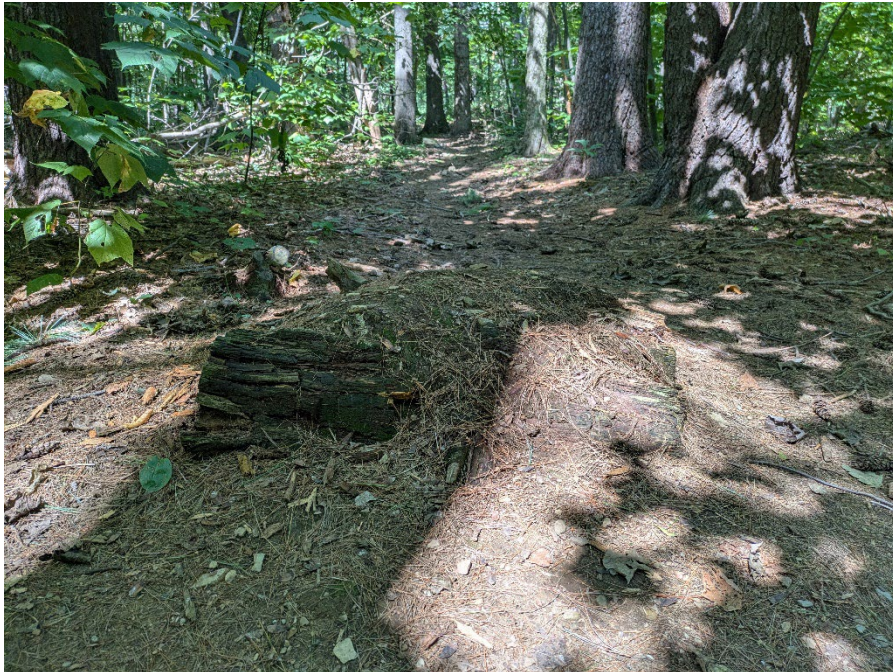
**Point 4** – Improvised mountain bike jump

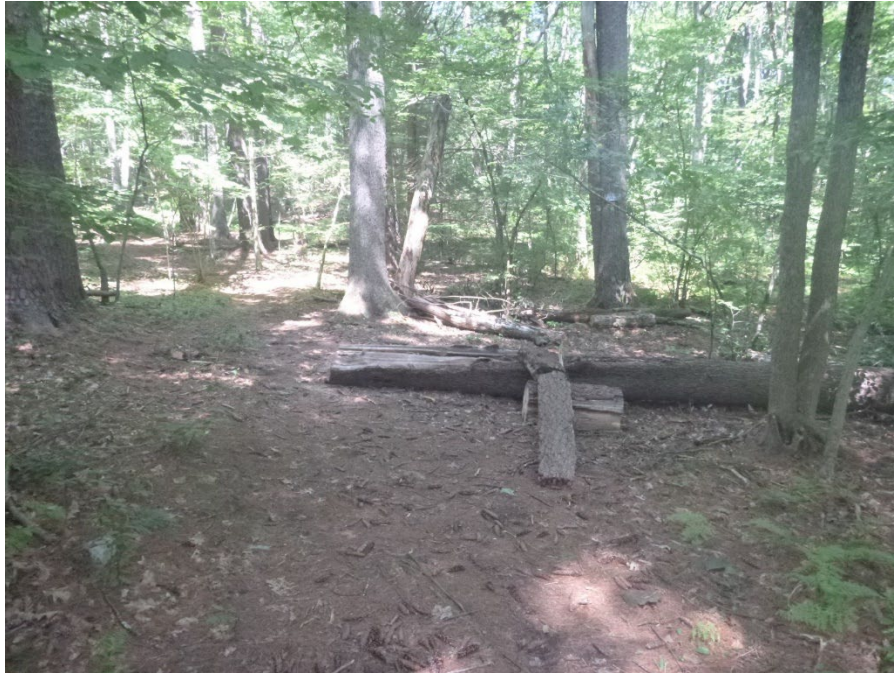
**Point 50** – Improvised mountain bike jump. While these mountain bike jumps are not a hazard per se, they do present a risk to those who use them and the city should be aware that they are there.

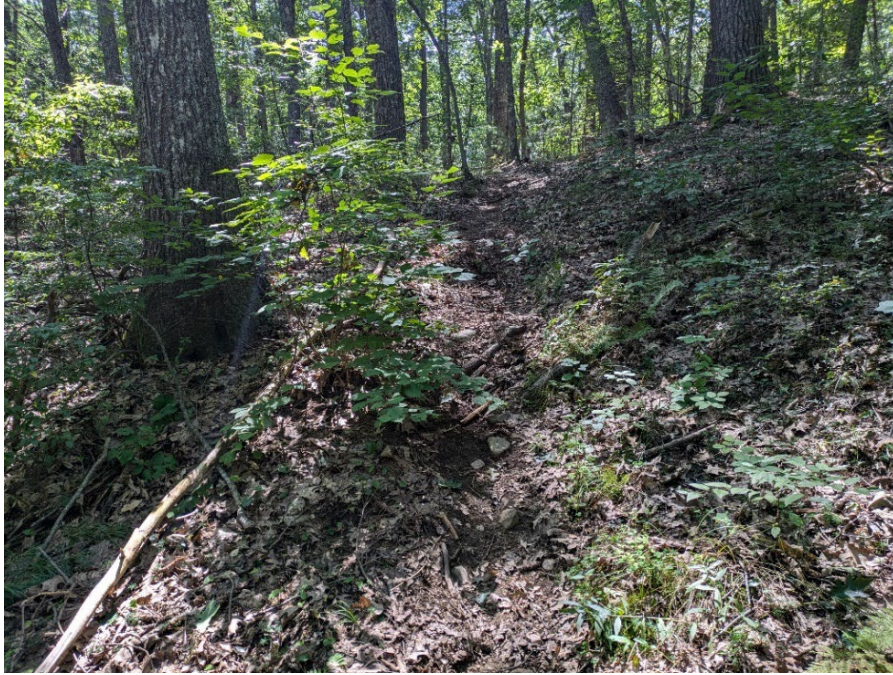
**Point 15**

Shaping a trails surface to periodically shed water at low points will help in the correction of tread erosion. Water can be controlled by contouring a trail. The edge of the trail can be cut down to allow water to drain off and the trail surface can be contoured to direct water towards the low area on the edge of the trail. These drain areas can then be periodically inspected to clear any debris which get caught in them. This is a low impact and relatively low maintenance way to control water issues on the trails. Trails that funnel water down the center of the trail rather than periodically having points designed to shed water will wash out over time. As an alternative to contouring a trail, water bars could be installed to direct water off the trail surface.

The locations we noted that would benefit from water control on the trail surface are points, 5, 15, 17, 21, 22, 28, 36, 37, 39, and 44. Two of these points are pictured below.

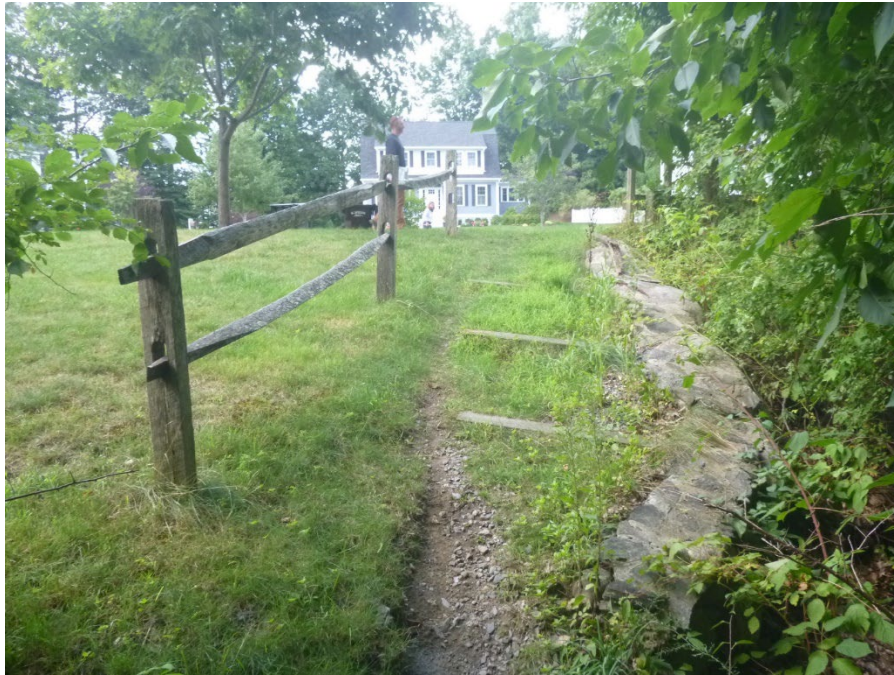
**Point 55**

At the beginning of the Margaret Rice Conservation Area trail there are a series of wooden water bars on a grassy slope section of the trail. As can be seen in the photo below, taken at point 55, water has found a route around the bars, causing some erosion. These water bars should, ideally, extend to the area below the fence, instead of stopping short of it.

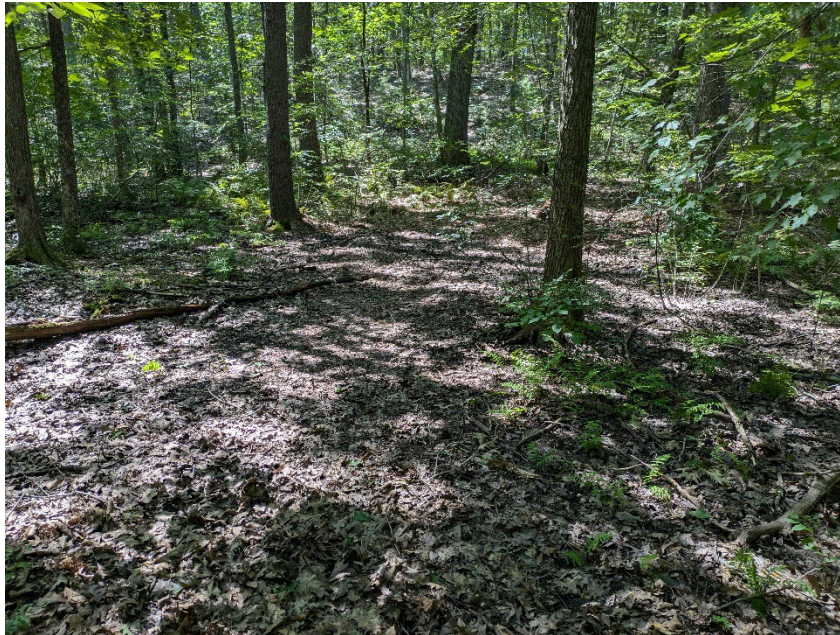
**Point 8** – The trail crosses a wet depression with no improvements in place. A bog bridge could be used here to cross over the wet area.

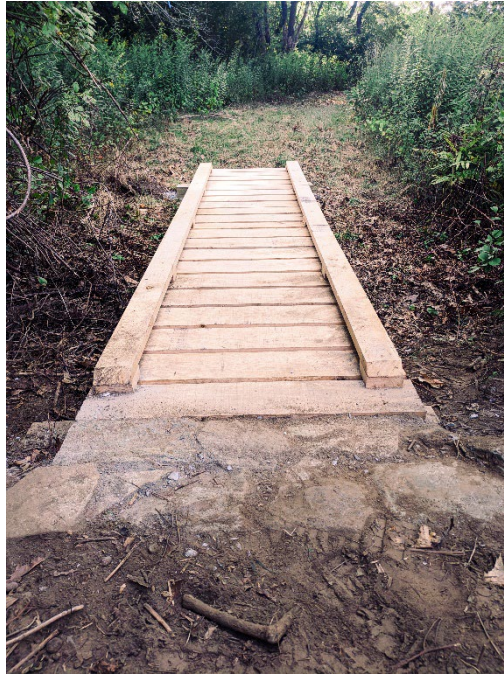
There are different ways to build bog bridging, one example of a bog bridge over a wet depression is shown here. The bridge is built using 6x6 footings on each end with two 4x6 beams providing support and a 4x4 down the center. The decking is built from white oak.

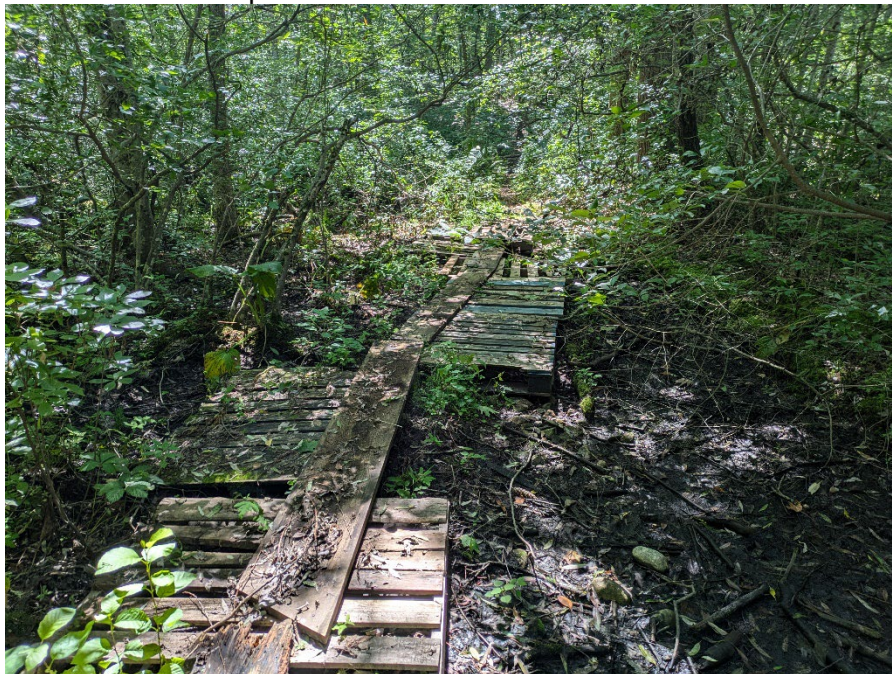
**Point 9** – Old pallets and boards are used to cross a wet area. Replacing this with bog bridging would provide a safer and more permanent solution.

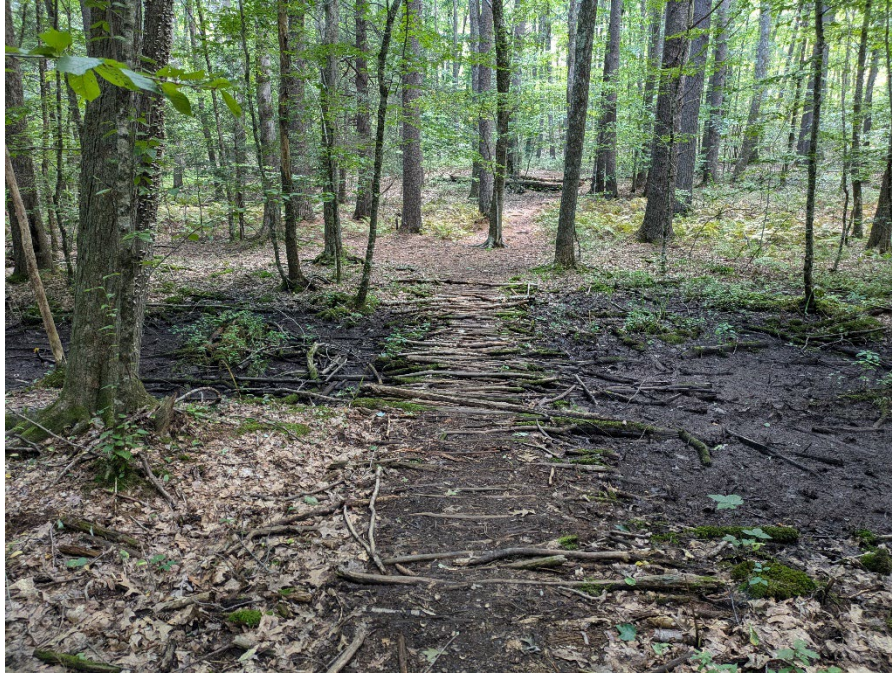
**Point 19** – A wetland is crossed using a corduroy of available logs and sticks. Replacing this with a bog bridge is a more permanent solution.

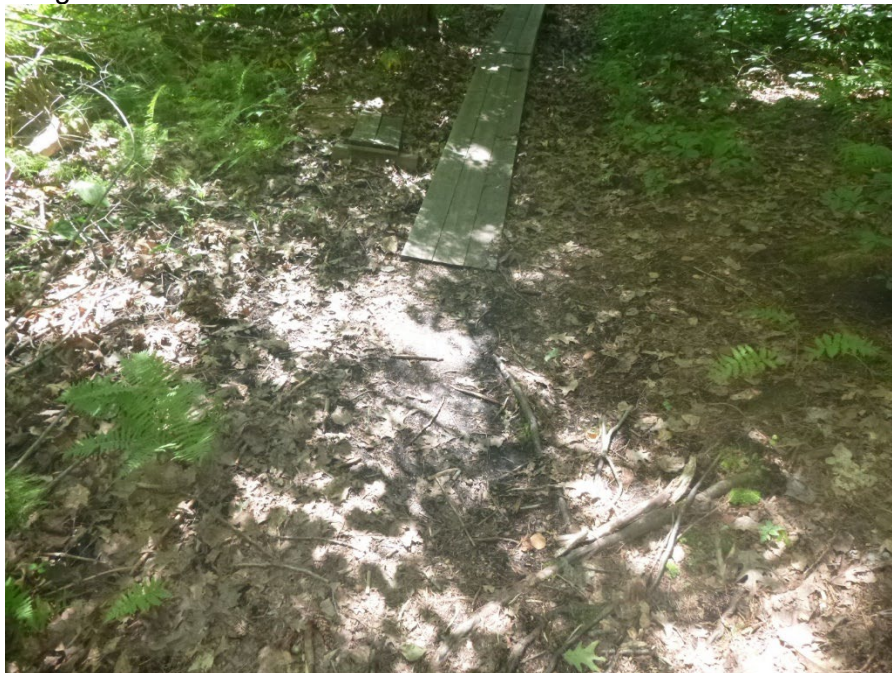
**Point 30** – There is a bog bridge in this location that is in acceptable condition, but it is next to the remnants of an old bog bridge that should be removed. Additionally, a rock transition could be added to the beginning of this bog bridge to control erosion, as shown in the photo of the example bog bridge.

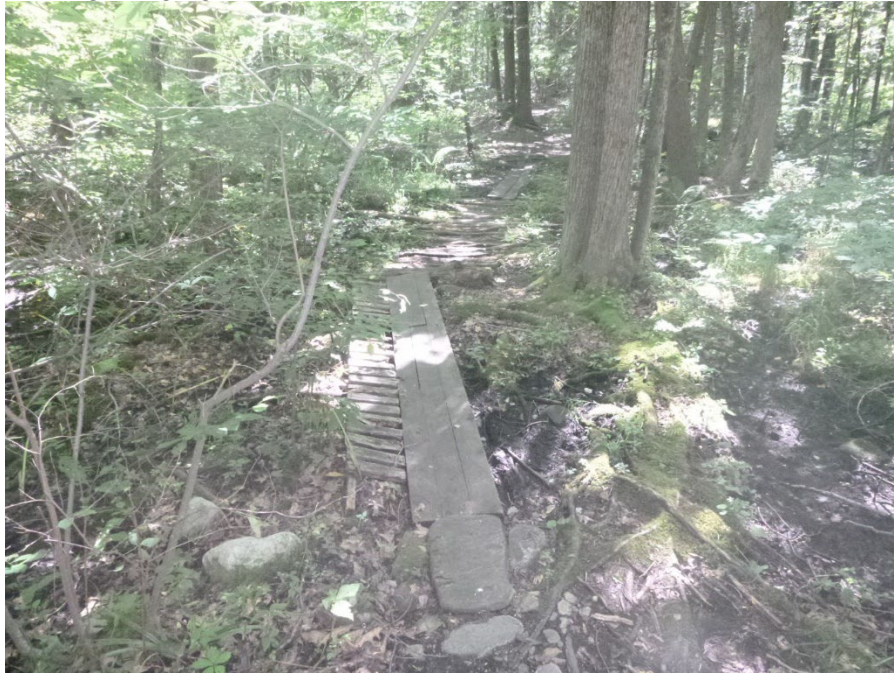
**Point 31** – This section of trail crosses approximately 60 feet of wetland. The wooden planks used to cross this area are beginning to fail and the existing log corduroys could be replaced by more permanent bog bridging.

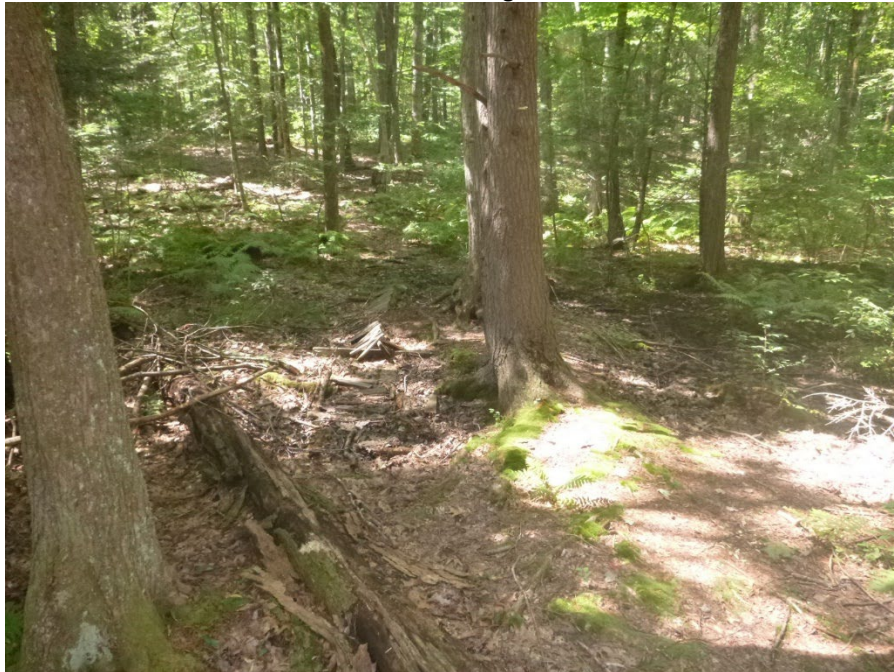
**Point 45** – The existing bridge at point 45 has failed. The wooden debris and protruding nails from the old bridge are blocking the path, causing users to find their own way around the wet area. The debris should be removed and a new bridge constructed.

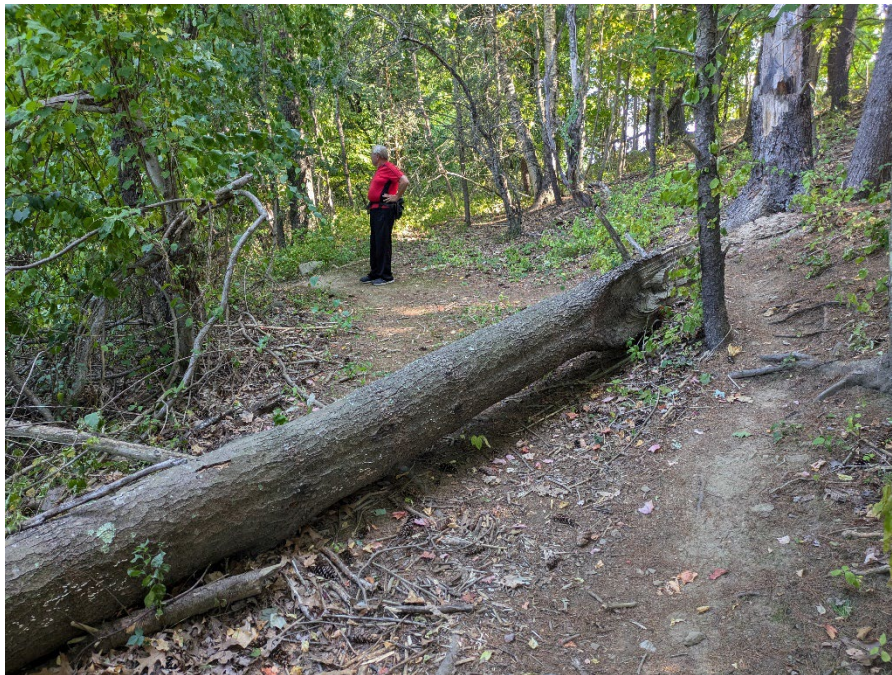
#### **Point 3**

The hazards we observed are located on the south half of Woodsom farm. The first hazard is a downed tree at point 3, which blocks most of the trail. Some users may struggle climbing over or moving around this tree. The second hazard is a dead tree hanging out over the trail at point 5. Hanging dead trees next to the trail should be removed, as eventually they will fall and block the trail, in a worst-case scenario they could fall and injure a trail user. The last hazard is at point 12. There is a drainage associated pit located here, the cover for this pit is simply a piece of metal laid over the top. The metal can be moved, which creates a fall hazard for users, additionally people could enter the pit if they wanted to. The loose piece of metal should be replaced with a top that can lock. These hazards are shown below.

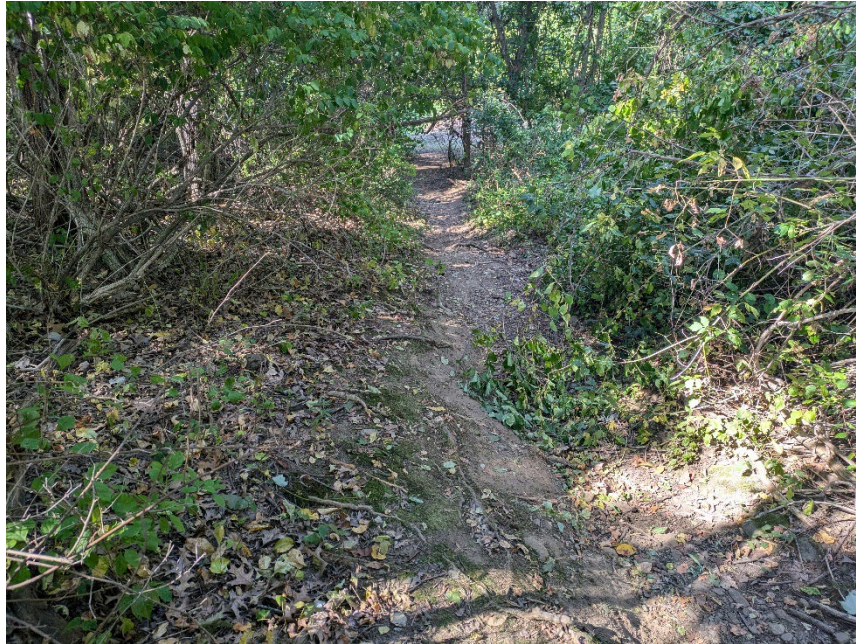
At point 4, there is a steep section of uphill trail that is suffering from some significant erosion on the lower side of the trail. There are two different options which would both work in this situation.

**Point 4** – Photo 1, existing erosion on the trail and a view of the upslope side of the trail. The trail tread could be moved to the left side of the photo and the existing trail would serve as drainage.

The trail is situated, so that if looking downhill at the trail the left side is higher than the right. Vegetation along this high left side could be trimmed back and the surface of the trail moved to the higher left side, with drainage down onto the existing trail tread, which would now serve as a drainage ditch area. Alternatively, the trail could be completely re-routed to go across slope in the area between points 3 and 4, and the existing trail closed. The terrain and vegetation in this area appear well suited to the construction of a new trail here.

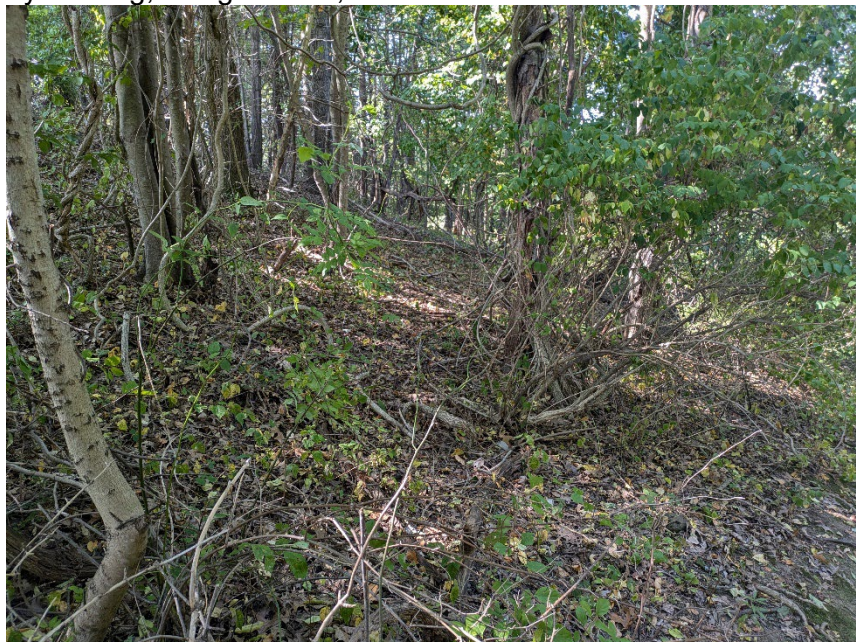
**Point 4** – Photo 2, a suitable location to re-route the trail to go across the hill's slope, rather than the currently existing, straight down, trail.

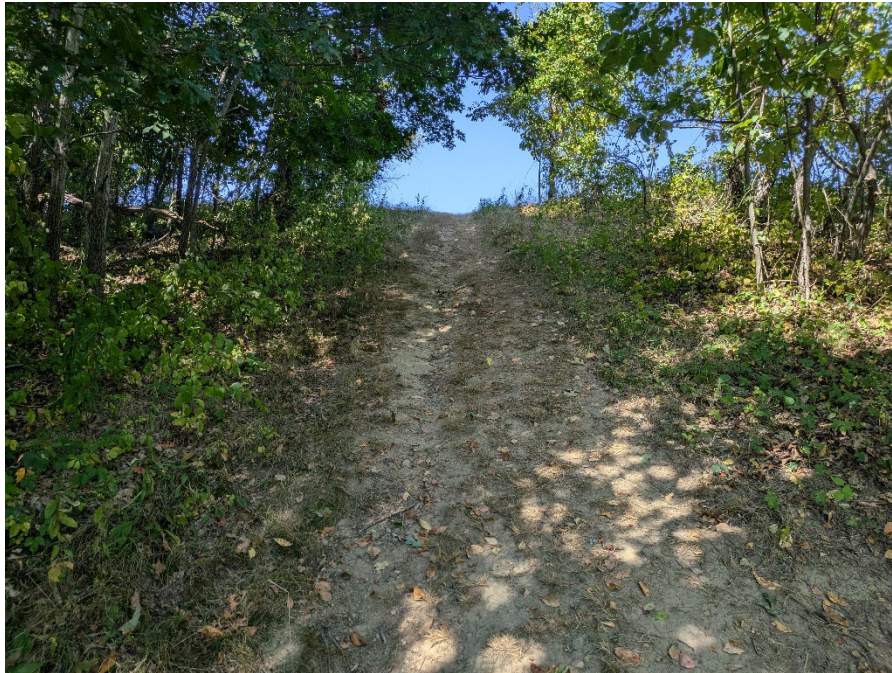
At point 11 there is a steep section of trail that heads straight down a slope. This path provides water with an easy straight down route with no resistance. Since there are no curves on this path where contouring could be easily accomplished for drainage, the best solution would be to install a couple of water bars to break the flow of water and direct it off the trail.

**Point 11** – As can be seen in this photo water is starting to create a channel along the left side of the trail surface. Water bars should be installed to break the flow of water and direct it off trail.

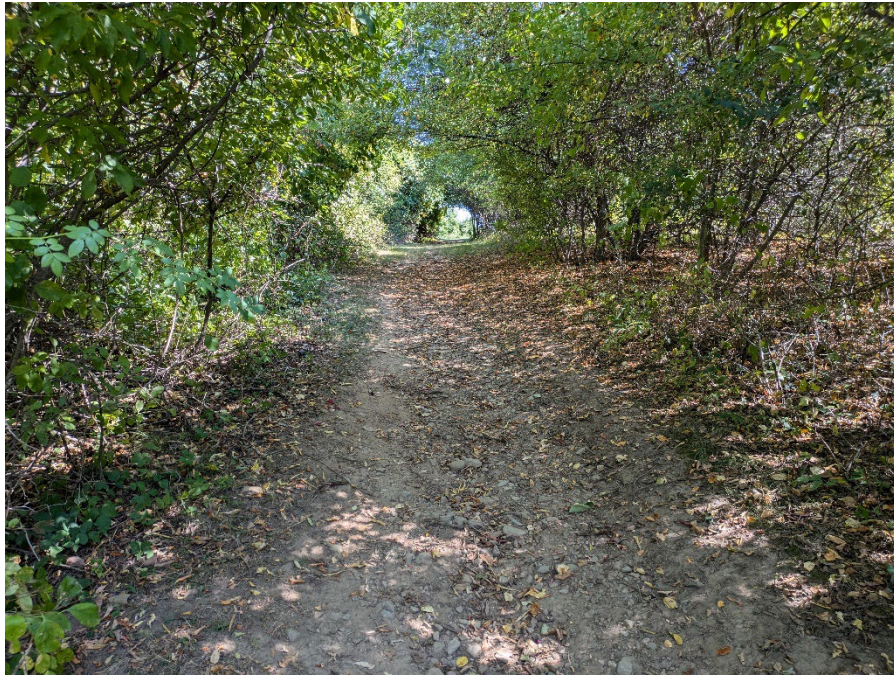
**Point 7**

There are two additional areas where water control is needed on the north side of Woodsom Farm. At point 7, there is another section of straight steep trail where a water bar could be installed to direct water off trail. At point 14 the farm road is starting to erode on a steeper slope. Point 14 could be fixed with contouring as it is along a gentle curve in the road. The lip of the road could be lowered and the road contoured to shed water off the side. Photos of these points are shown below.

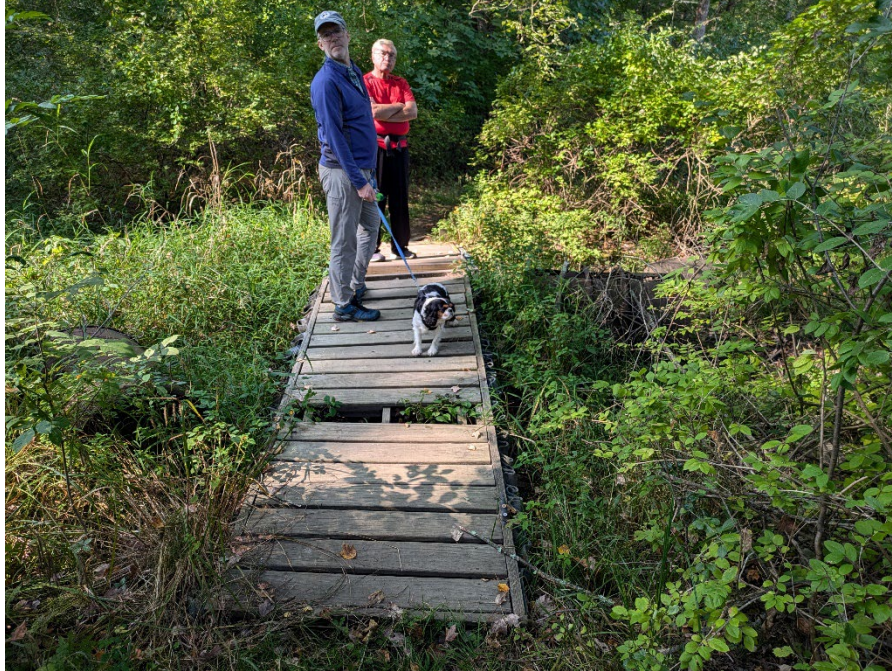
The first is an existing bridge at point 1. This bridge is simply in need of repair as there are some missing boards. In this same location there is a board used to bridge a small wet area just

**Point 1** – The existing bridge in need of repairs.

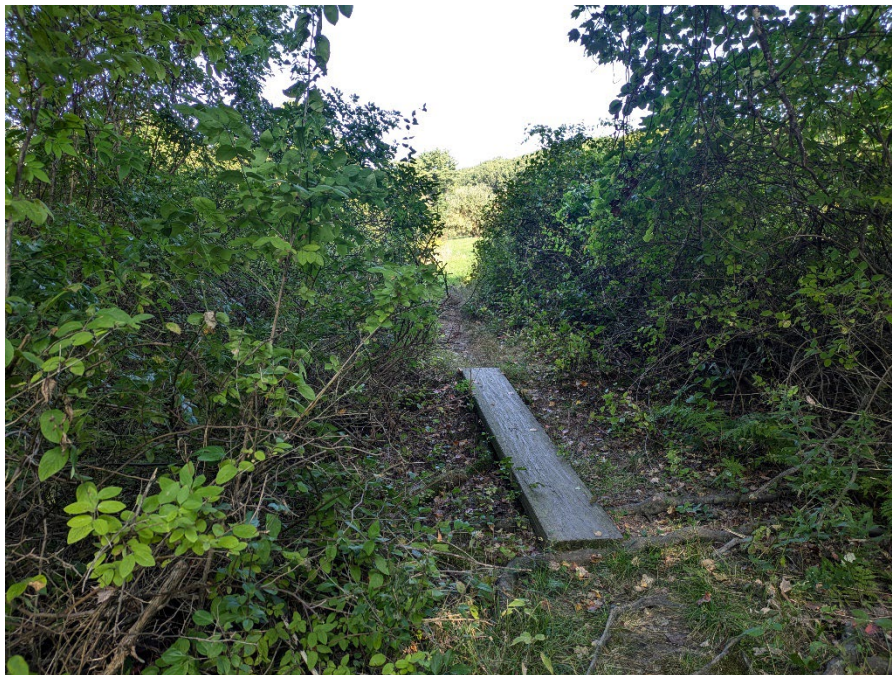
prior to this bridge, the board is currently nailed into some tree roots. This could be improved by adding some 4x4 footers on top of crushed gravel that the board can be attached to, instead of the tree roots.

**Point 1** – Board nailed into tree roots

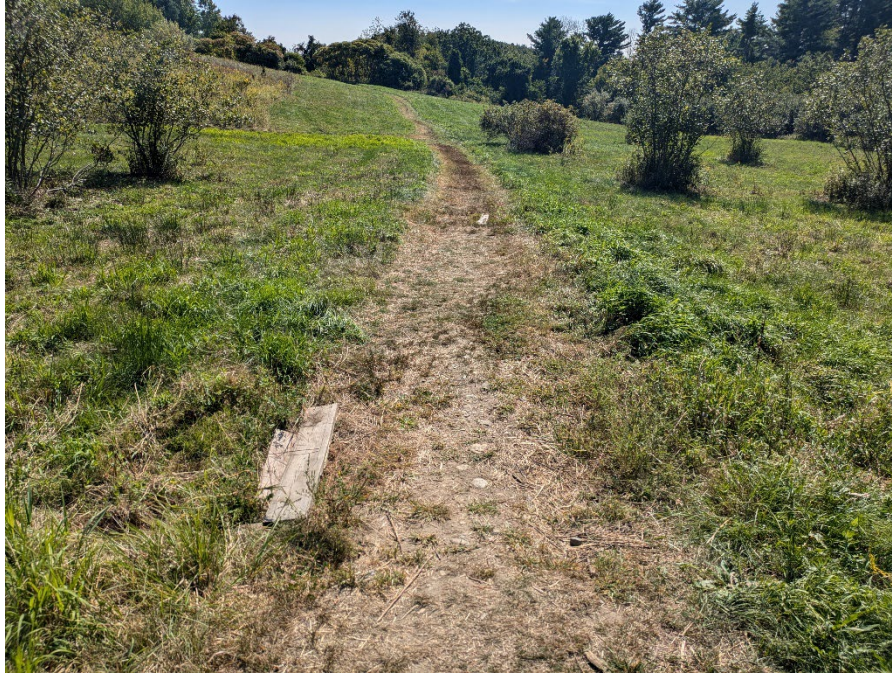
At point 9 there are a few low dips in the trail with some boards noted on the trail side, likely used by trail goers when the low dips are muddy. This area could be improved with either small bog bridges, or by rock armoring the trail. Crushed gravel could be used to fill in these low spots

**Point 9 – Low dips in the trail surface**

and larger stone could be set into the crushed gravel as a surface for trail users to walk on. A small bog bridge is likely quicker and easier to construct, but either solution would work.

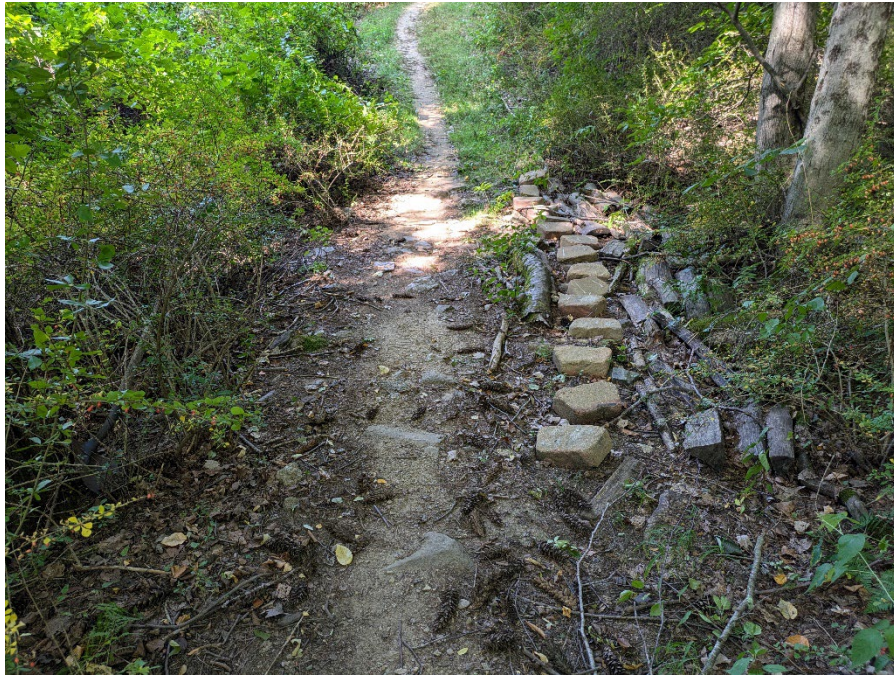
**Point 13**

At point 13, on the north side of Woodsom Farm, there is a spur trail that heads off the property to the east. Just before the trail leaves town property there is a low point, where it appears a seasonal stream may cross the trail. As can be seen in the photo below, trail users have created a temporary crossing by loosely placing stepping stones along the edge of the trail. A bog bridge could be built to cross this seasonally wet area. Alternatively, the stones that users have already brought in could be used to create a more permanent rock armor solution. Small gravel could be used to build up the trail surface and the stones set firmly into this gravel to create a trail surface, the gravel should allow the water to flow through and the stones should be set high enough that they are out of the water.

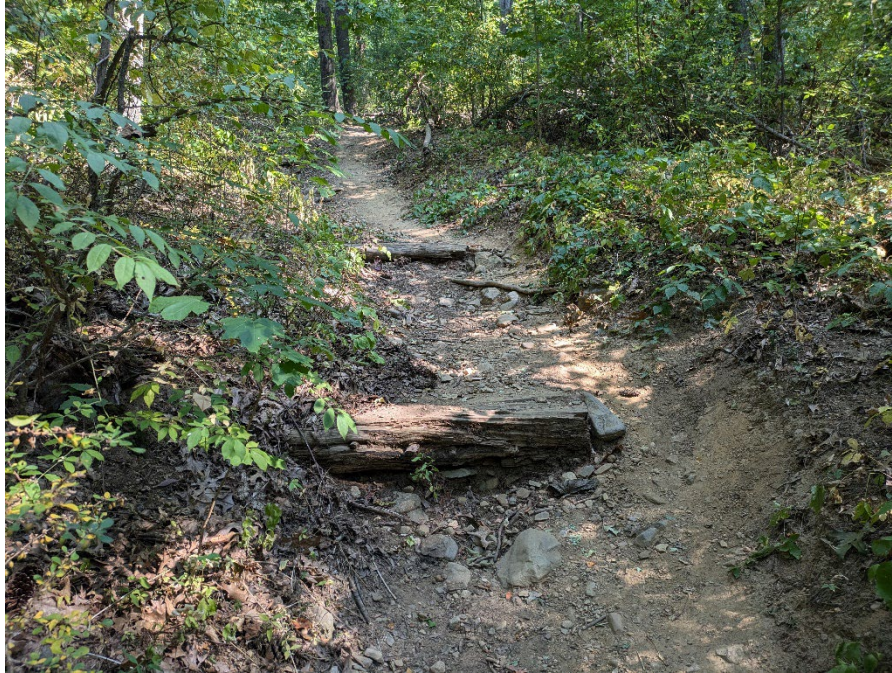
At point 13, on the Batchelder Trail, there are a series of steps installed on the tread that are helping to control erosion and direct water. The soil in front of one of these steps has washed out, creating a larger than normal drop from the top of the step to the bottom. This could be a tripping hazard to users and the bottom of the step should be filled in with soil or gravel to bring the drop back to a normal step level.

**Point 13 – Soil washed out at bottom of step**

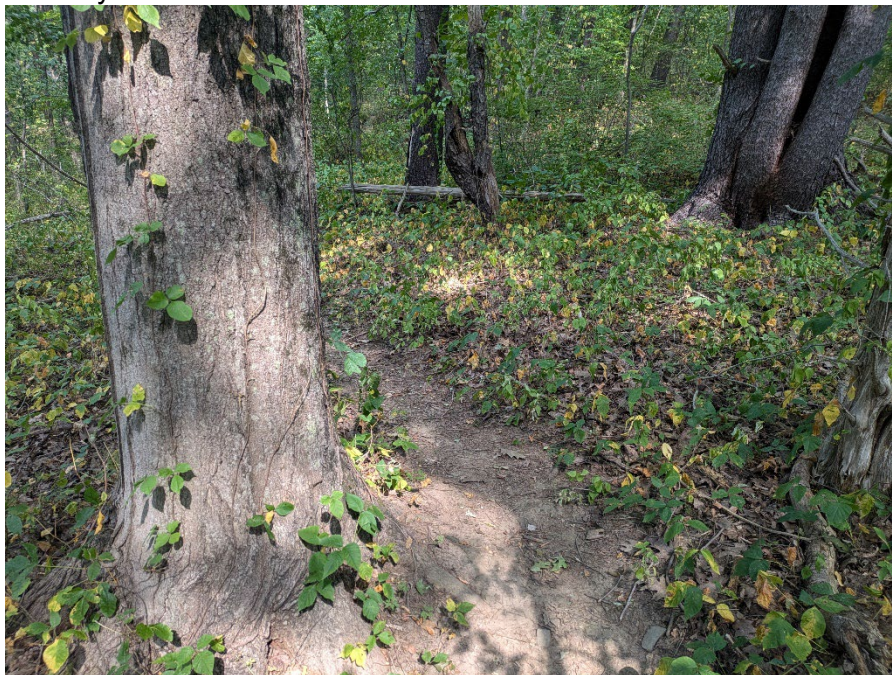
At points 15 and 24 there are large amounts of poison ivy surrounding the trail and some of this poison ivy is beginning to hang over the trail tread. The poison ivy will likely need to be continually controlled to ensure that it does not present a hazard to people on the trail.

**Point 15 – Poison Ivy on the trail**

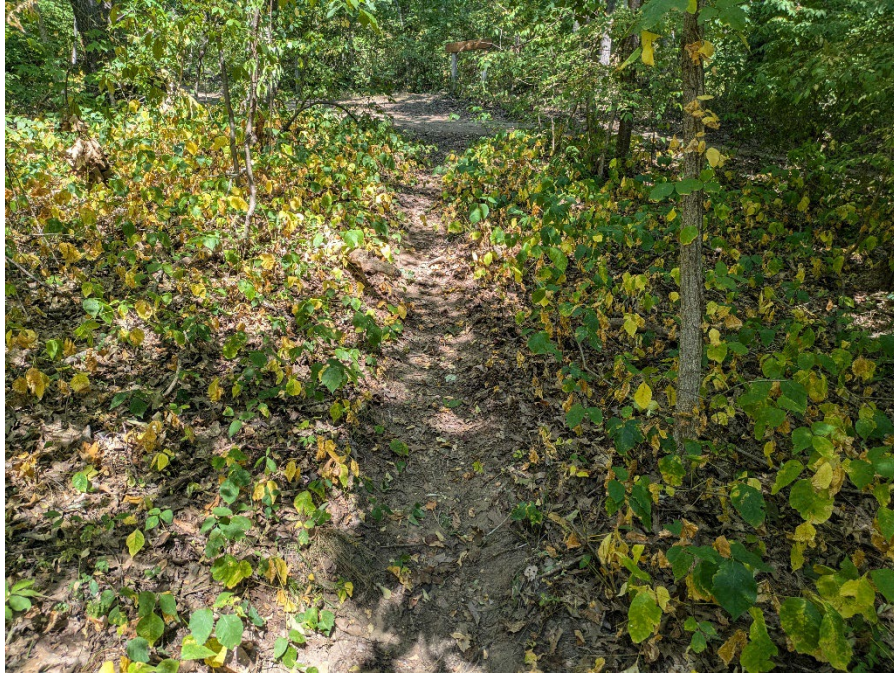
**Point 24 – Poison Ivy on the trail**
