## **Trails Assessment Report City of Amesbury**

Prepared by Woodsman Inc  
Site Visit Dates: 8/23/2024, 9/12/2024, & 9/13/2024

**Town Forest &  
Margaret Rice Conservation Area**

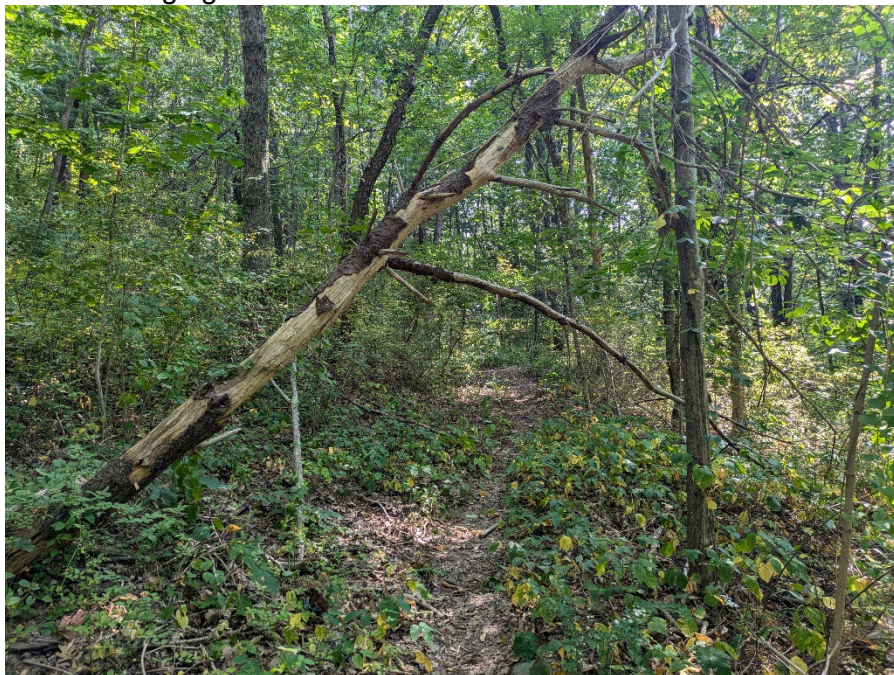
While on the property we noted two hazard trees which should be removed. One of these hazard trees is located at point 20, while the other is at point 23.

**Point 20 – Dead tree hanging over trail**

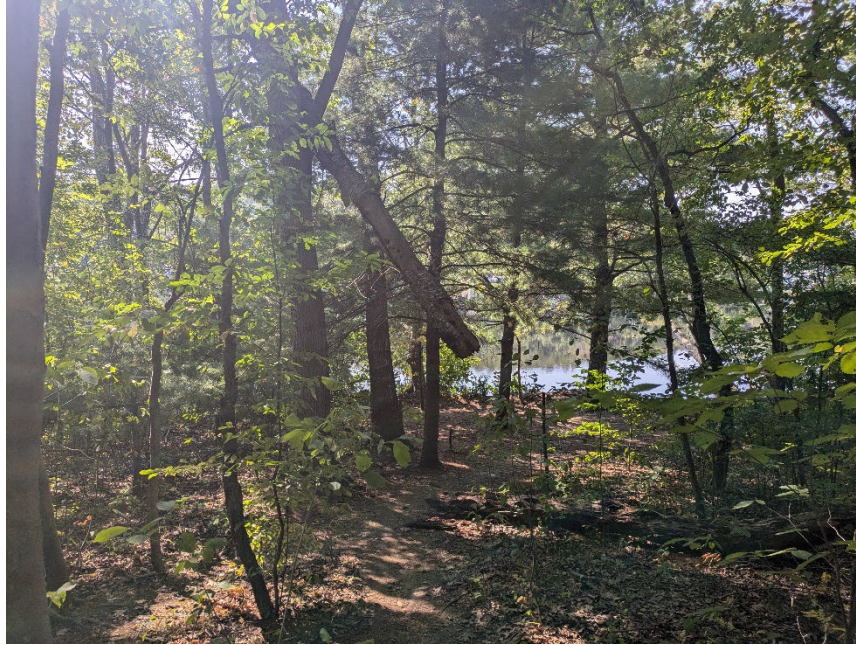
**Point 23** – Snapped off tree suspended in the air above the trail. This tree should be removed to avoid the potential that it could fall on a trail user.

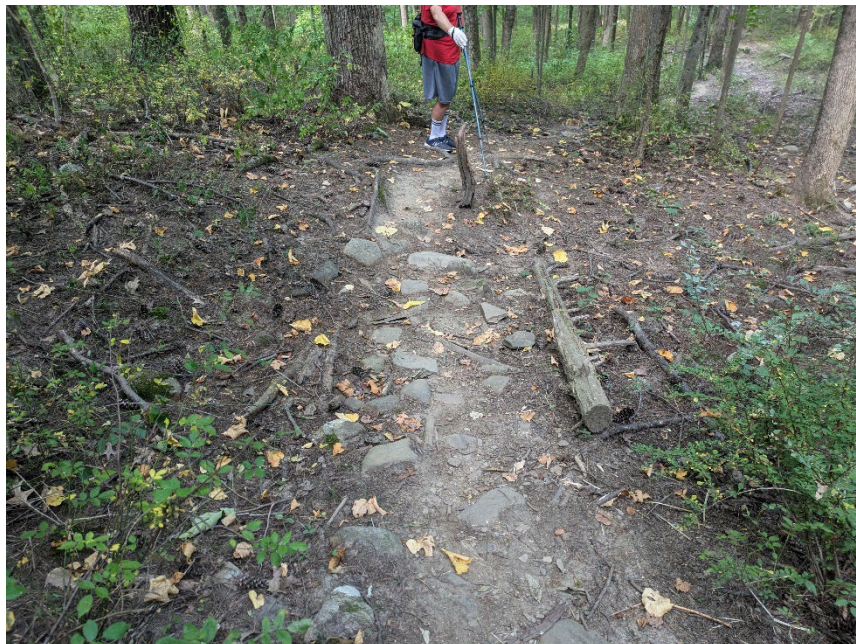
The first location is at point 9 on the Powow Trail. There is a low dip in the trail where a seasonal stream crosses over the trail and flows to a low spot on the opposite side. A bog bridge could go across this dip and raise the trail surface above the water.

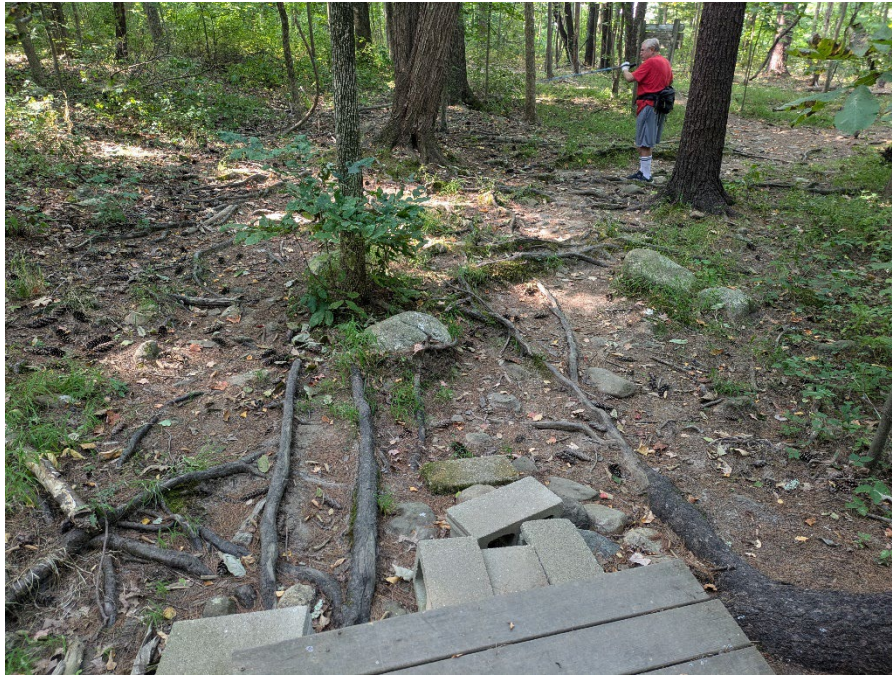
At point 11 a currently existing bog bridge stops just shy of the end of the wet area.

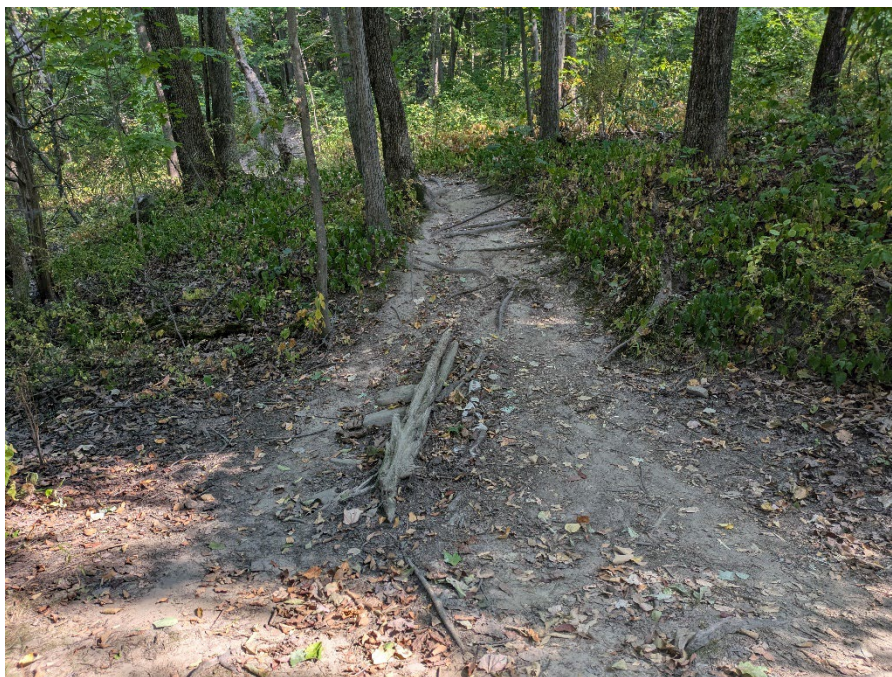
**Point 12** – A small plank bog bridge is needed to cross a seasonally wet, low depression in the trail.

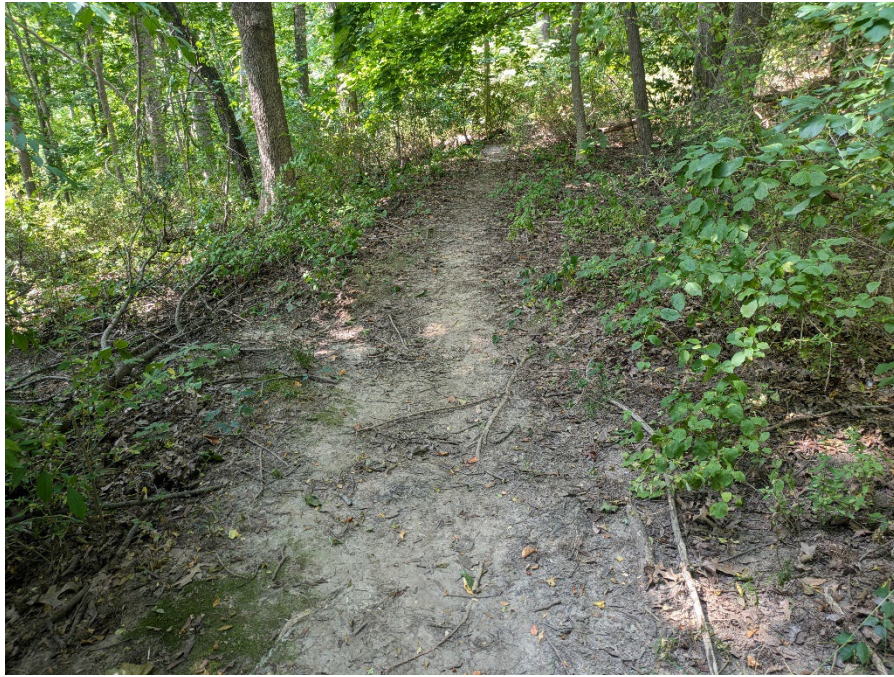
**Point 17** – This point is located on a spur trail that leads off the property towards Orchard Court. There is a low point on the trail with a seasonal stream that could be crossed with a small plank bog bridge.

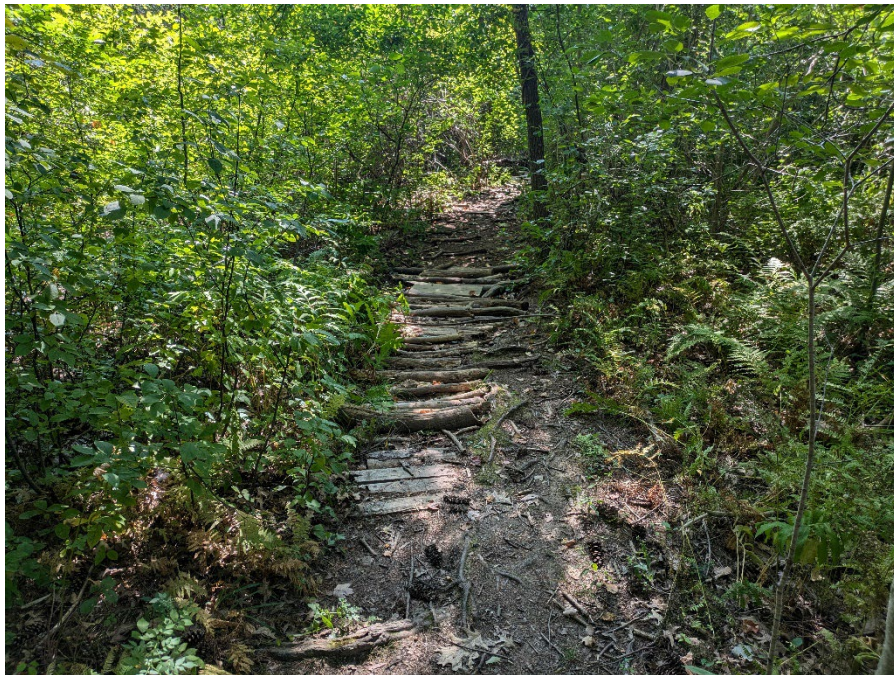
**Point 22** – This area is located on Camp Kent. A wet area is crossed using a log corduroy as well as some old wooden planks. This should be removed and replaced with a more permanent bog bridge.

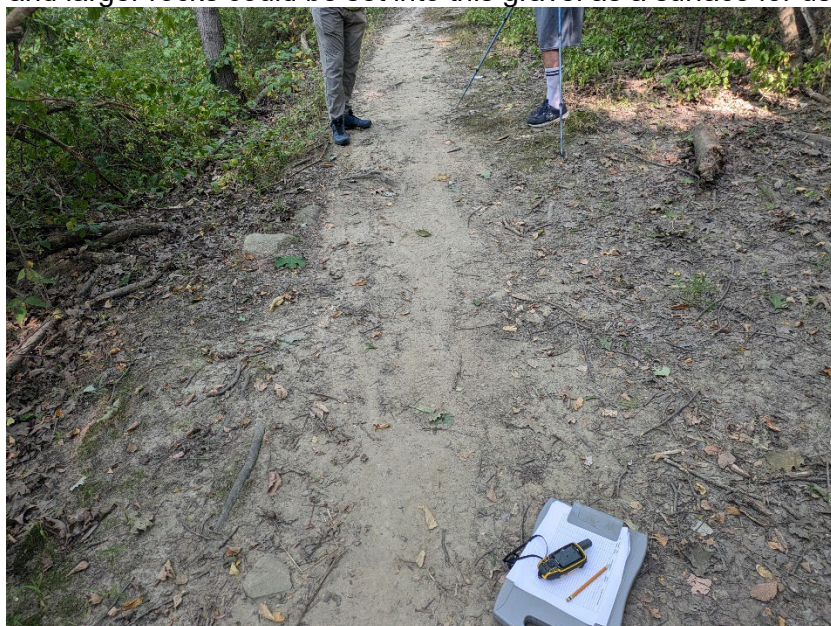
**Point 2** – Point 2 is a low dip in the trail where water flows across. This could be fixed by a bog bridge, but it could alternatively be fixed with rock armoring. The dip could be filled with small diameter gravel and larger rocks could be set into this gravel as a surface for users to walk on.

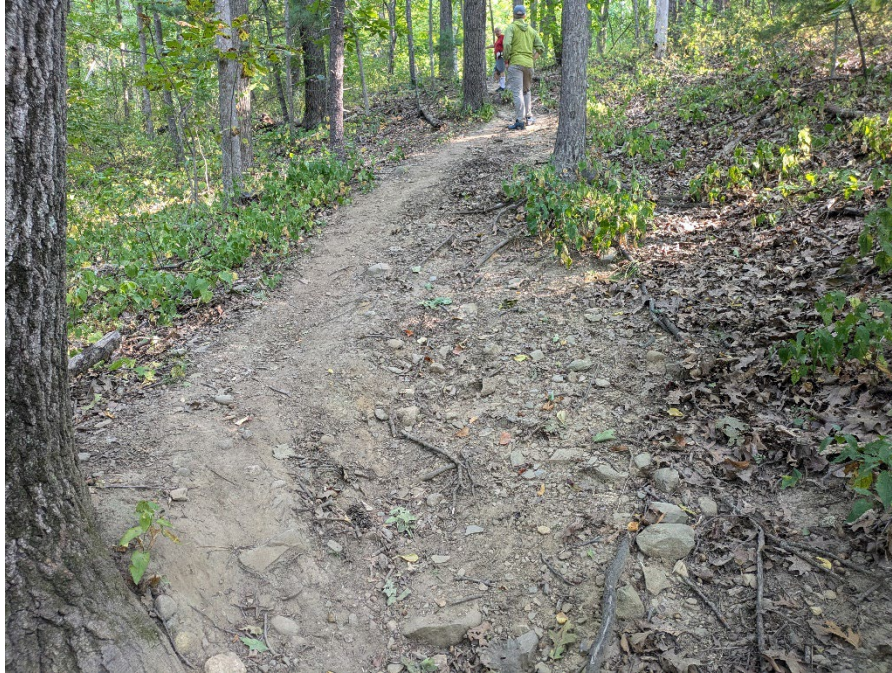
**Point 3** – This area is located at the bottom of the Silvermine Trail where it connects to the Stagecoach Trail. Flowing water is beginning to wash out the trail tread. A series of water bars/steps could be installed here. This would help to hold in the soil and break the flow of water as well as provide a comfortable series of steps for users to walk down. An alternative solution would be to re-route this section of trail across the slope of the hill to the northwest, to create a more gradually sloping connection to the Stagecoach trail.

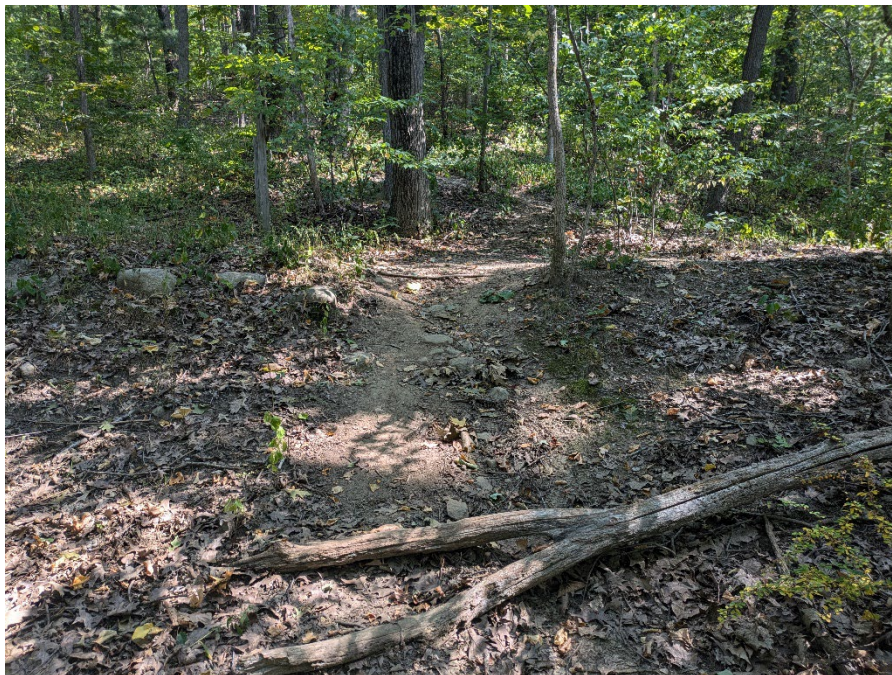
**Point 19** - The spur trail heading down to the lake, directly across Stagecoach Trail from the Silvermine Trail is also suffering from the same erosion issue. If steps/water bars are added at point 3, they should also be added here.

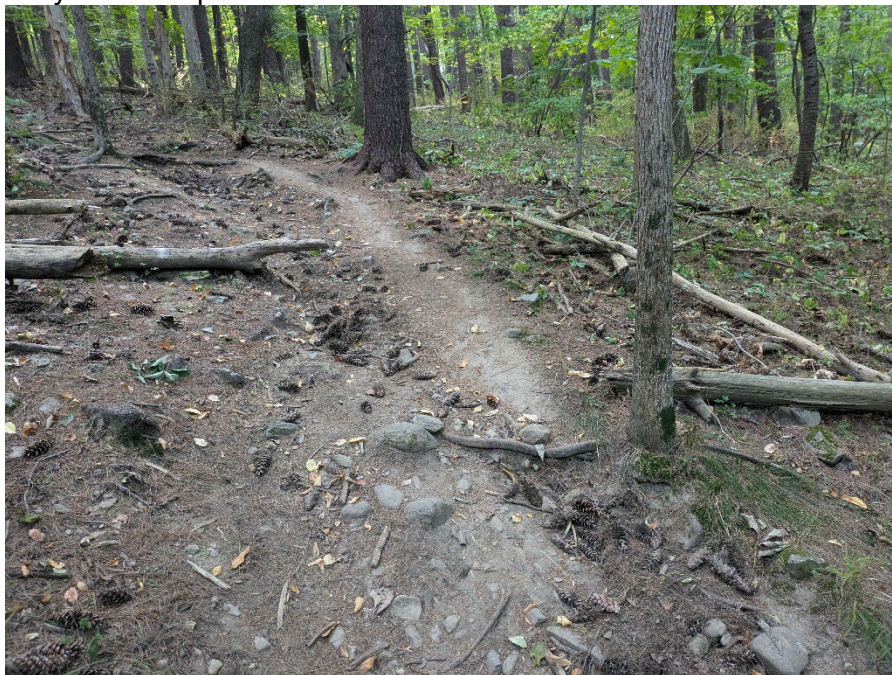
**Point 7** – This is a good spot to add a water bar. As can be seen in the photo, water is flowing down a low valley in the center of the trail. By adding a water bar here and directing all this water off the trail you will help to minimize water issues and erosion further down the trail.

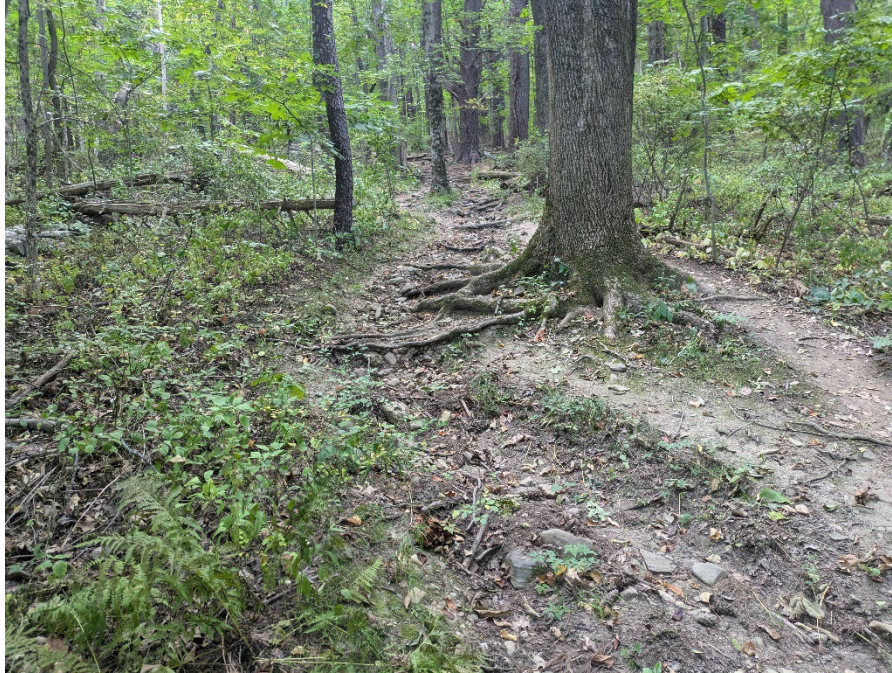
**Point 8** – At point 8 there is heavy water flow following the trail tread. As can be seen in the photo the water is flowing down the left side of the trail, while the right side of the trail is higher. Users should be directed to the higher right side of the trail and the lower left side of the trail should be dedicated to the flow of the stream. In some areas this may take a bit of work to remove obstacles and high points that are blocking the flow of water to keep water flowing in the low areas and to keep the trail tread on the higher ground.

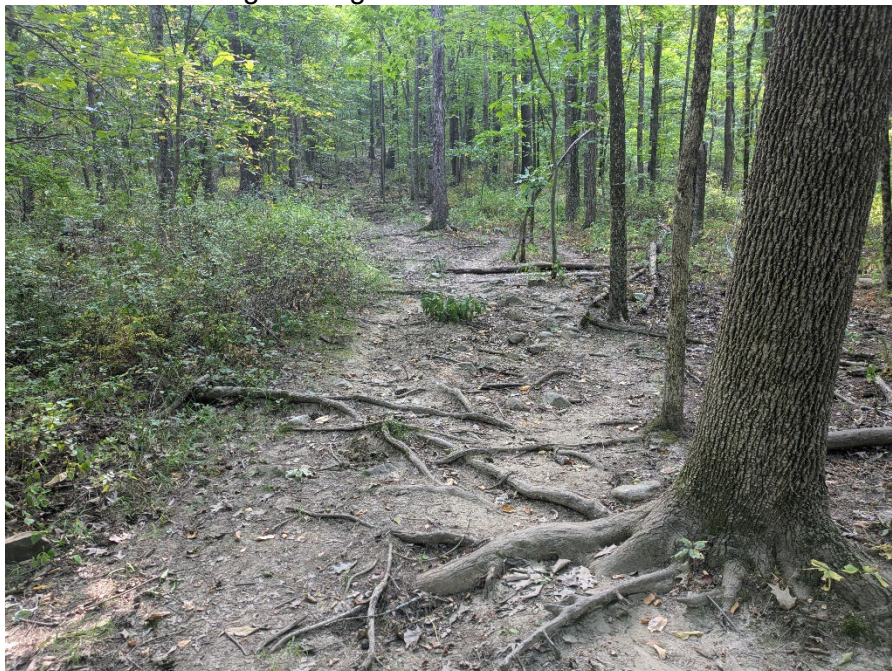
**Point 10** – This is a low point on the trail where water is flowing over it during the wet season. During our visit we noted that there are many large, loose rocks scattered throughout this trail. These rocks can be used for rock armoring to cross wet areas. This section of trail would be a good candidate for rock armoring to bring the trail surface above the wetness.
